M.Y Property Inspection LLC

REPORT HEADER

1: GENERAL

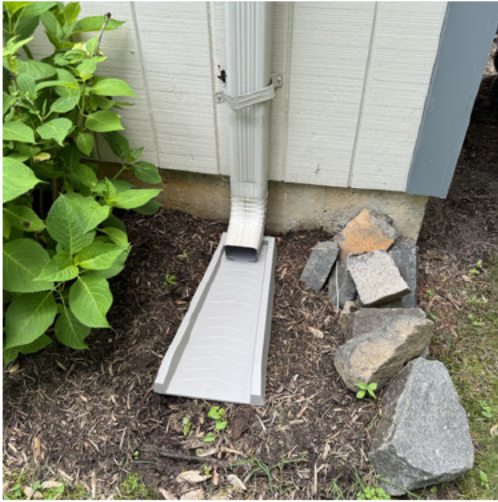
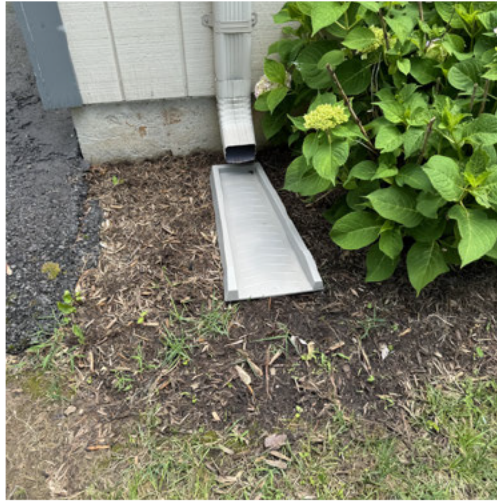
Exterior Gutter
Downspout

- It is highly recommend to place an extension on the gutter downspout to keep the water away from the house.

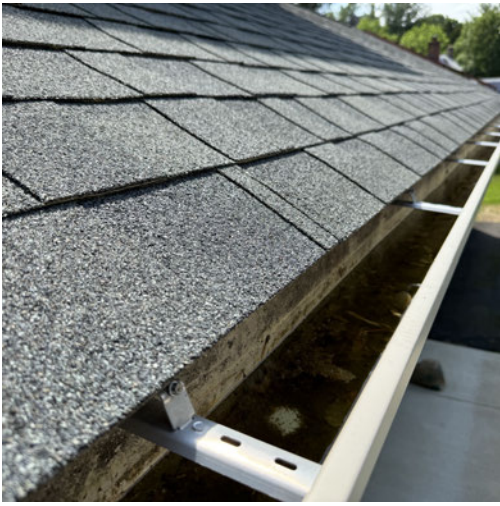
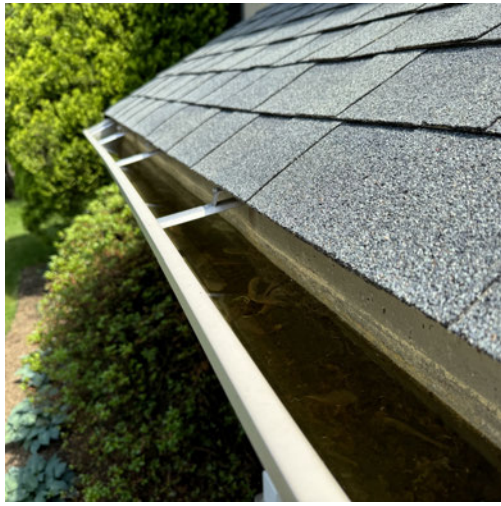
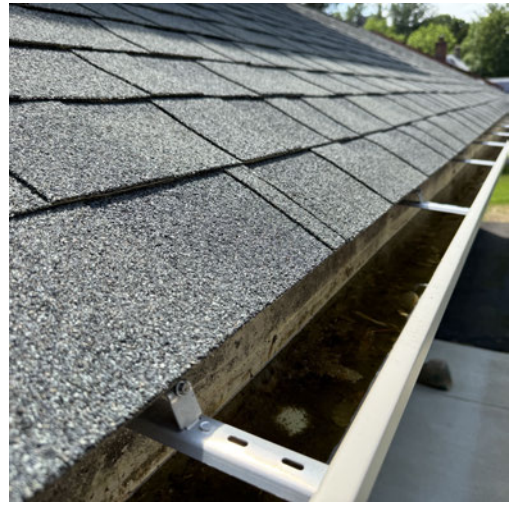
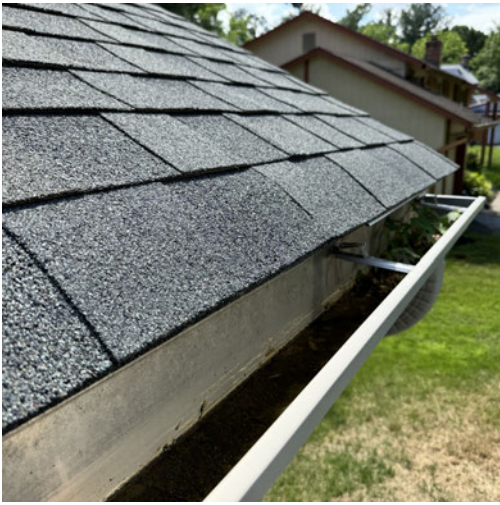
Front Yard Gutter

- Standing water was found in the gutter.
- Plants was found growing in the gutter.
- The uneven slope on the left portion of the gutter prevents the water to properly flow out from the gutter as shown in the photos.

- Remove all the plants and leafs in the gutter.
- Recommend to open an opening on the left side of the gutter to allow the water to flow out from the gutter system as discussed during the inspection.

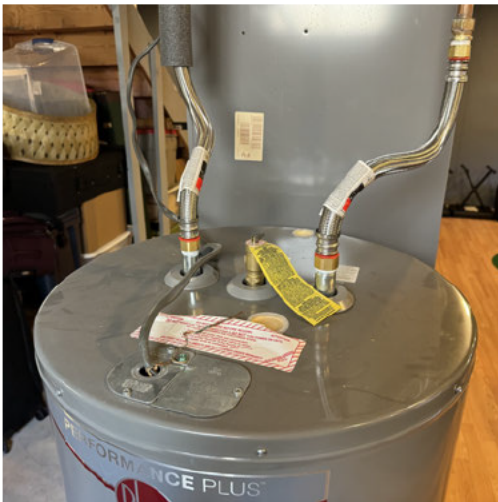
Water Heater

- The water heater tank is missing the temporary relieve valve (TPR Valve). This needs to be install because the temperature of the water that flow out from this valve is really high.

- Refer to water heater technician to evaluate the situation and perform proper repair.

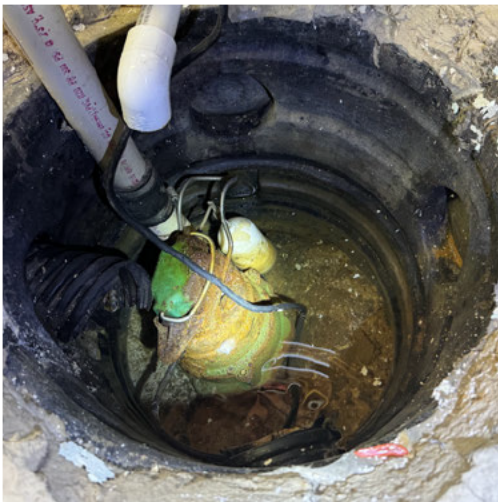
Sump Pump

- The sump pump is still functions properly, however, it is obvious that it past its life expentency.

- Highly recommend changing the sump pump in the upcoming days.

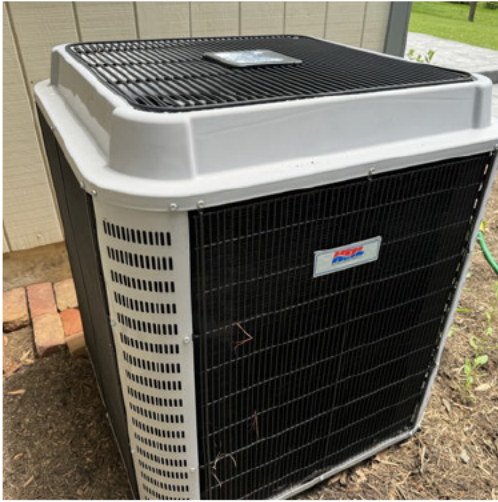
HVAC (Backyard)

- The HVAC system's position was found to be uneven after measured by a 4ft level.

- Refer to the HVAC technician in order to evaluate the situation and perform required re-alignment on the HVAC system.
- Perform annual maintenance on the HVAC system, such as cleaning the HVAC system.

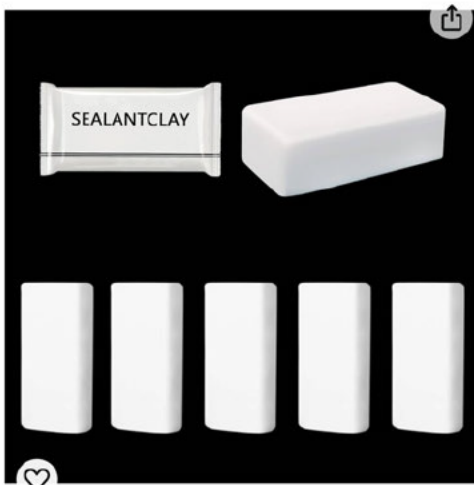
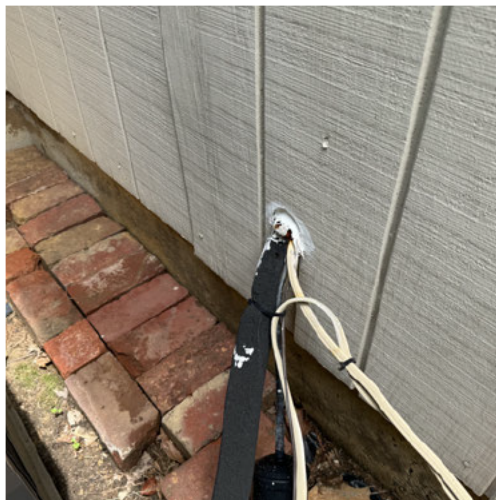
Air Conditional Line

- “Duct Seal Repair Sealing Clay” can be found on Amazon in order to close the voids between air conditional line and the wall.

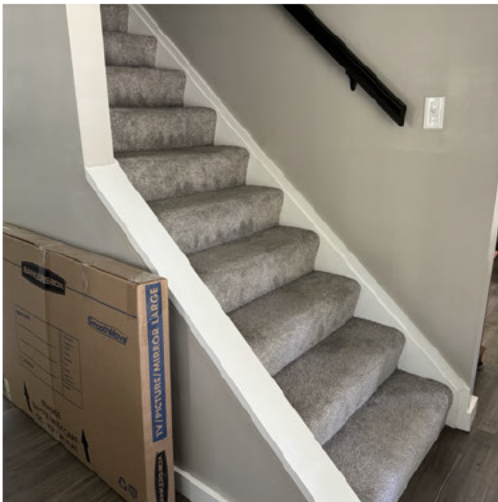
Staircase

- Handrail is missing as shown in the photo.

- Highly recommend to install the staircase handrail to prevent safety hazard especially when kids frequently use the staircase.

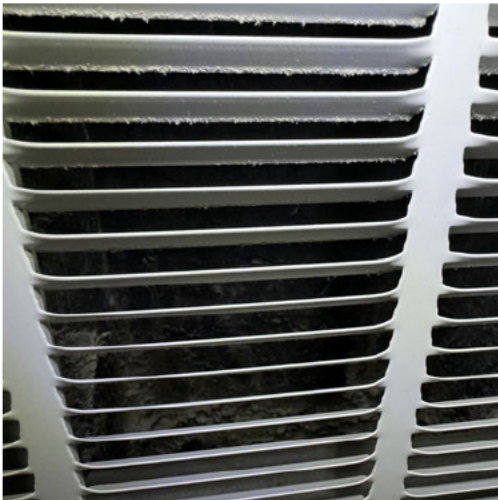
Air Duct System

- Thick dust lining was found in the air duct as shown in the photo.
- Highly recommend air duct cleaning company to clean the air duct system to prevent any respiratory sickness.

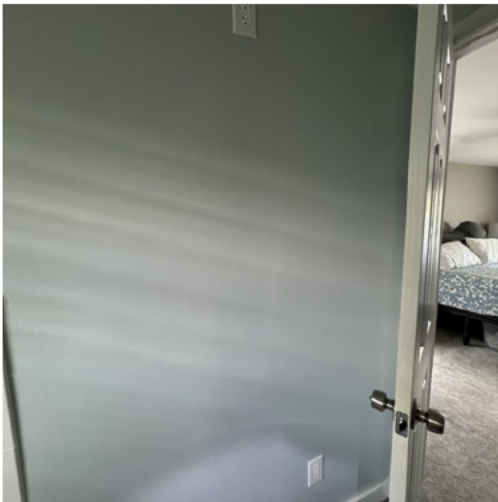
Master Bedroom
Bathroom

- The 2 electric GFCI outlet in the Master Bedroom are not working.

- Refer to electrician to evaluate the electric outlet.

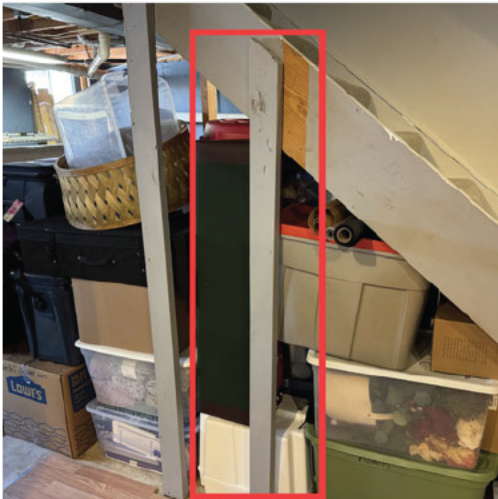
Basement Staircase

- The support of the staircase is loose as shown in the photo.

- Redo the wood column by removing the column, re-align the wood column, and tighten the wood column as discussed during the inspection.

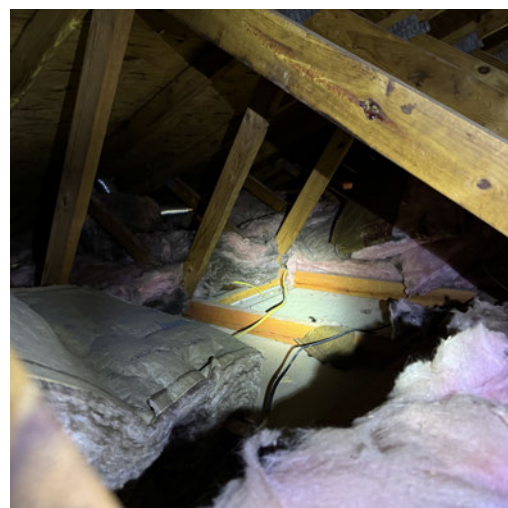
Attic (Hallway Area)

- Empty space was found uncovered by insulation as shown in the photo.

- Place the extra insulation material as shown in the photo.

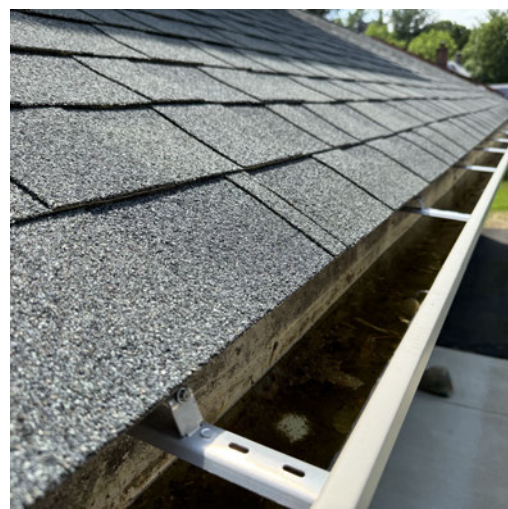
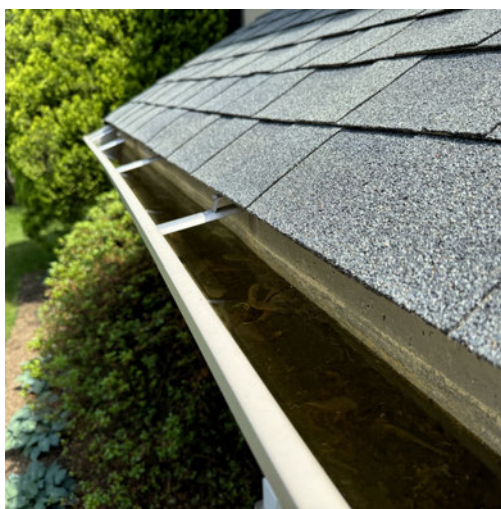
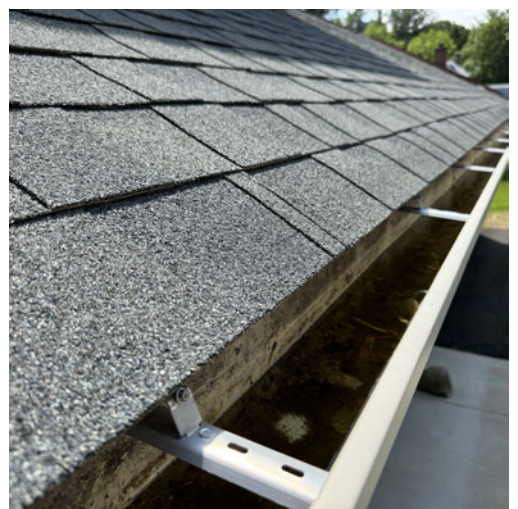
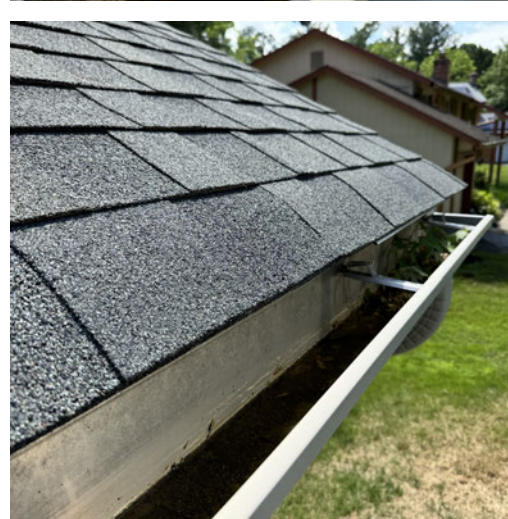
Front Yard Gutter

- Standing water was found in the gutter.
- Plants was found growing in the gutter.
- The uneven slope on the left portion of the gutter prevents the water to properly flow out from the gutter as shown in the photos.

- Remove all the plants and leafs in the gutter.
- Recommend to open an opening on the left side of the gutter to allow the water to flow out from the gutter system as discussed during the inspection.

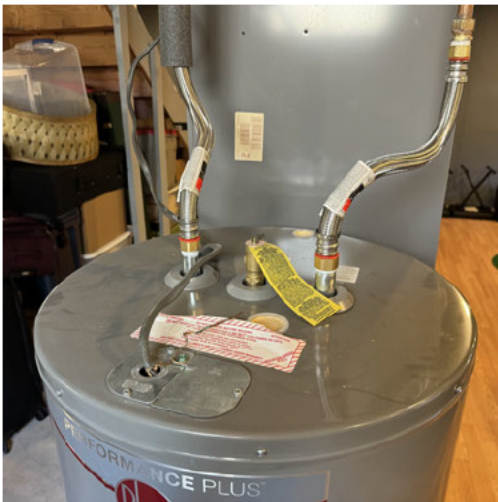
Water Heater

- The water heater tank is missing the temporary relieve valve (TPR Valve). This needs to be install because the temperature of the water that flow out from this valve is really high.

- Refer to water heater technician to evaluate the situation and perform proper repair.

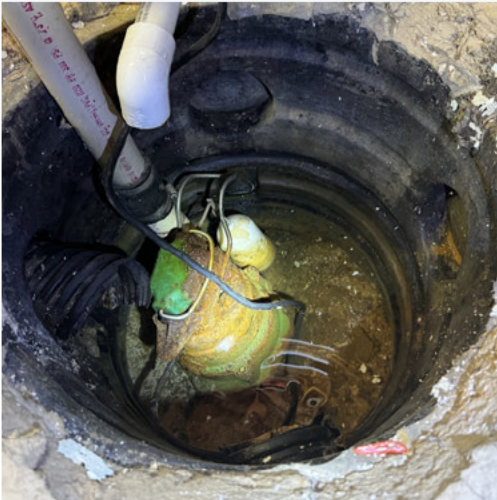
Sump Pump

- The sump pump is still functions properly, however, it is obvious that it past its life expentency.

- Highly recommend changing the sump pump in the upcoming days.

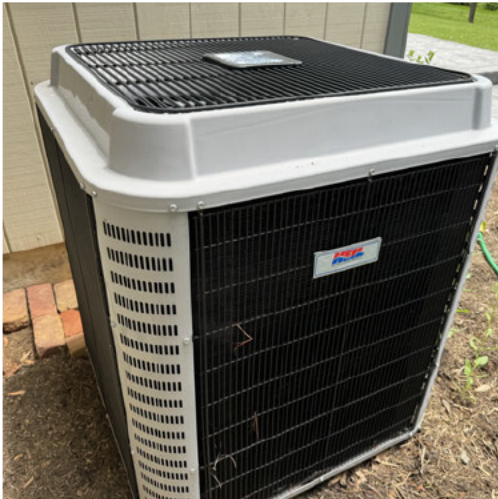
HVAC (Backyard)

- The HVAC system's position was found to be uneven after measured by a 4ft level.

- Refer to the HVAC technician in order to evaluate the situation and perform required re-alignment on the HVAC system.
- Perform annual maintenance on the HVAC system, such as cleaning the HVAC system.

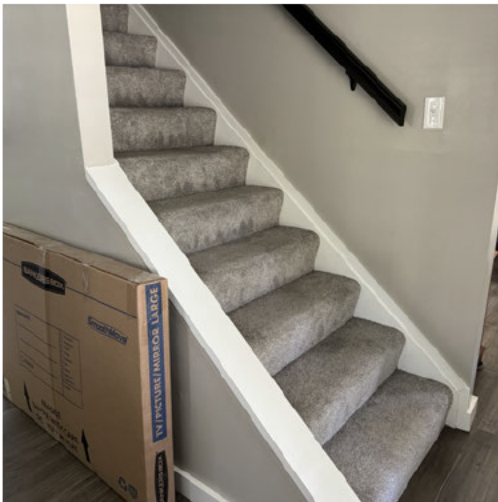
Staircase

- Handrail is missing as shown in the photo.

- Highly recommend to install the staircase handrail to prevent safety hazard especially when kids frequently use the staircase.

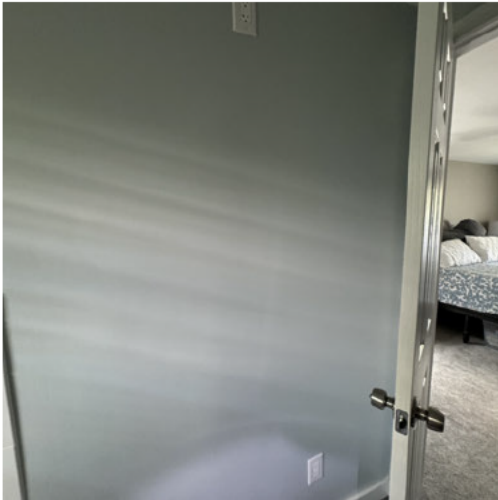
Master Bedroom
Bathroom

- The 2 electric GFCI outlet in the Master Bedroom are not working.

- Refer to electrician to evaluate the electric outlet.

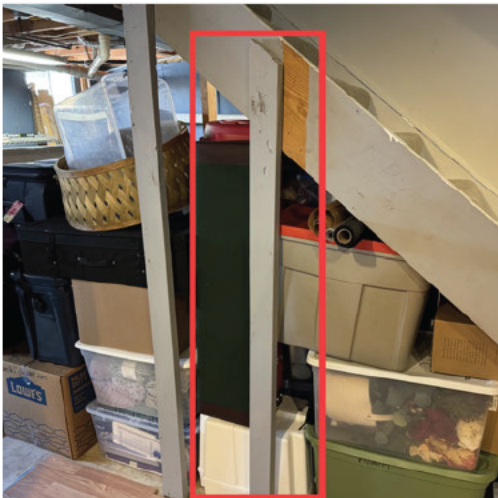
Basement Staircase

- The support of the staircase is loose as shown in the photo.

- Redo the wood column by removing the column, re-align the wood column, and tighten the wood column as discussed during the inspection.

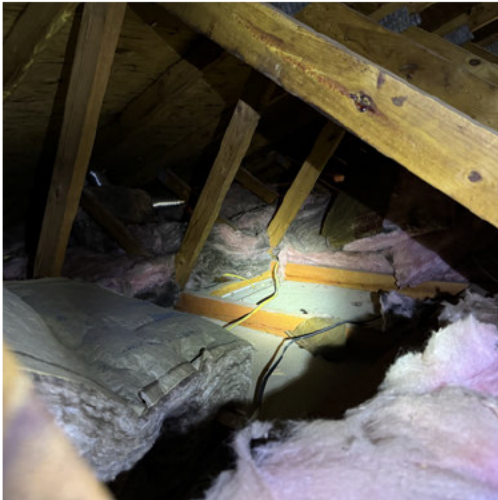
Attic (Hallway Area)

- Empty space was found uncovered by insulation as shown in the photo.

- Place the extra insulation material as shown in the photo.
