**M.Y Property Inspection LLC**

REPORT HEADER

1: GENERAL

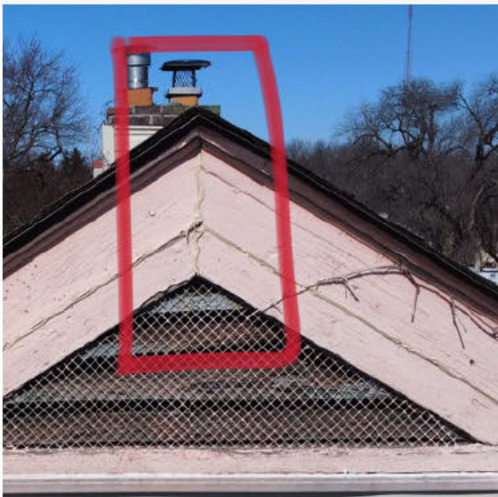
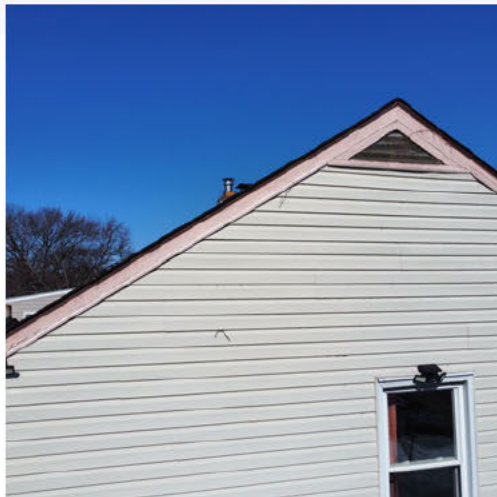
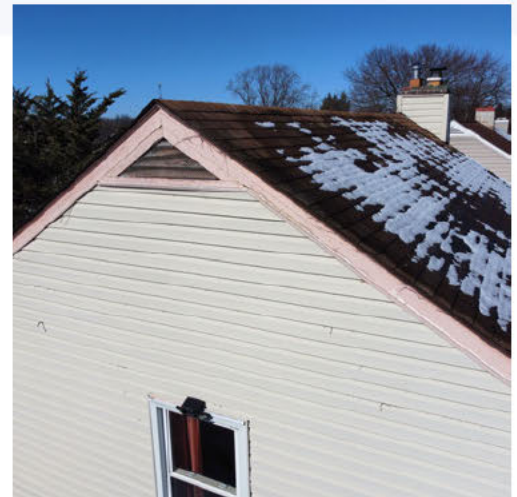
Right Side Of The Roof Top

- There is a sign of misalignment on the roof truss. The gap that caused by misalignment of the roof truss was filled with white silicon as shown in the photo.
- Tree/plant roots was found on the roof as shown in the photo.
- There are signs of rotten woods as shown in the photos.

- Highly recommend to check the history of the roof truss with current home owner in order to determine the cause of the misalignment.
- Highly recommend license roofing contractor to provide further evaluation of the situation.

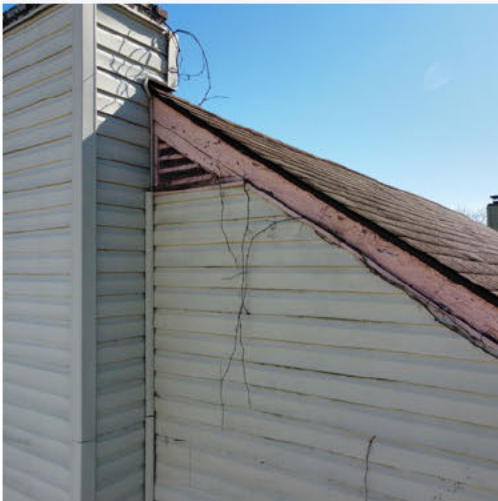
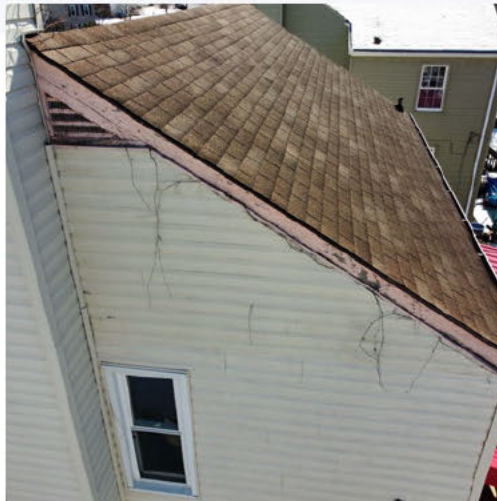
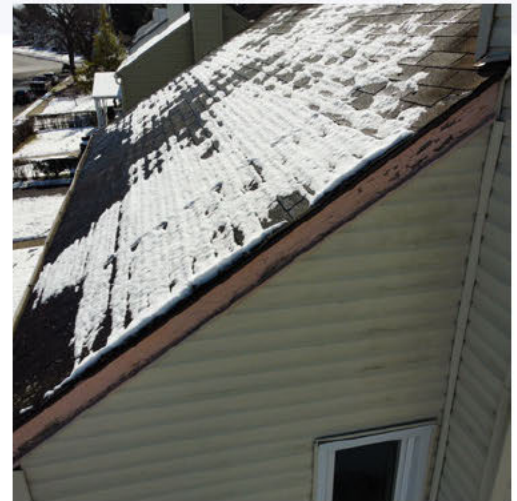
Left Side Of The Roof Top

- Tree/plant roots were observe as shown in the photo.
- There are signs of rotten woods as shown in the photos.

- License roofing contractor is require to perform further evaluation of the situation

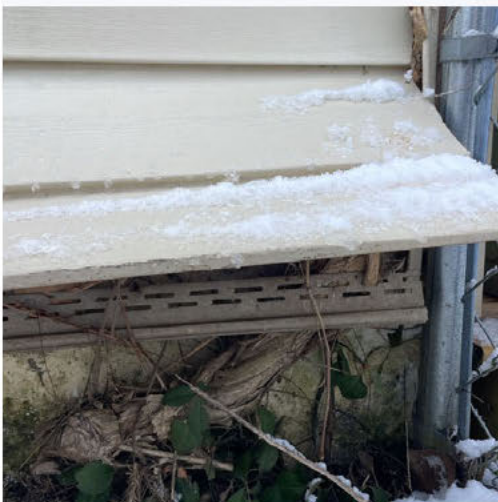
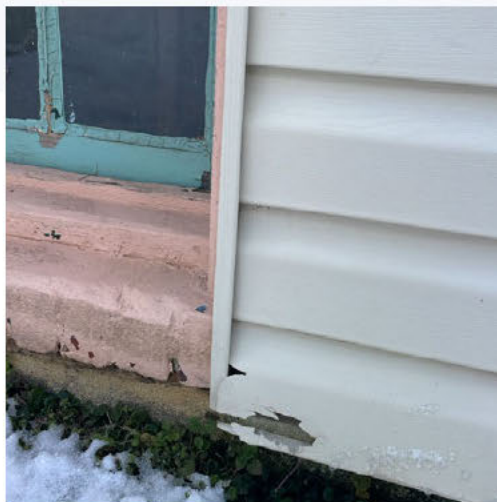
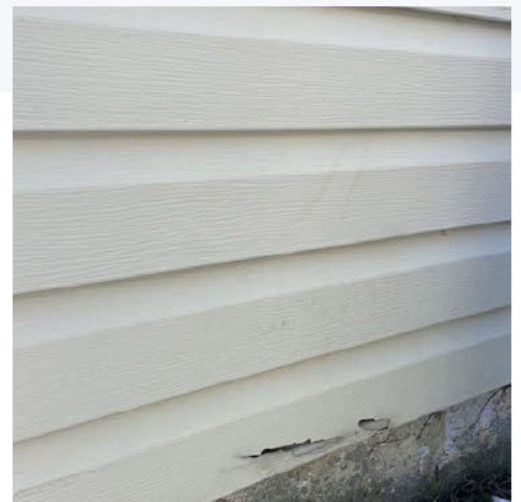
Left Side of The Property

- Tree/plant roots were found behind the vinyl siding and at the corner of the roof as shown in the photos. Couldn't perform further evaluation whether the tree/plant roots is still growing due to limited accessibility.

- Damaged vinyl siding was found as shown in the photos.
- Further evaluation by contractor is required

- Further evaluation by license contractor is highly recommended in order to mitigate the tree/plant roots continue to affect the exterior and foundation of the property.

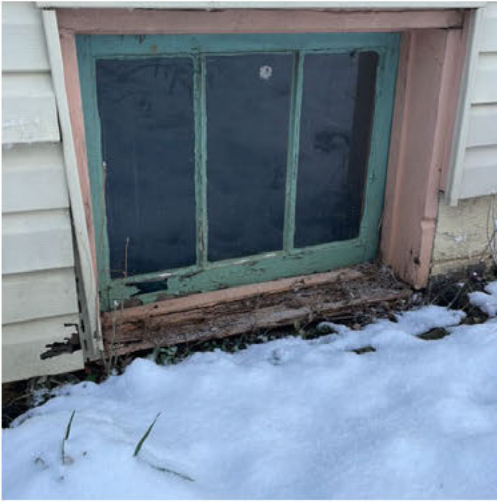
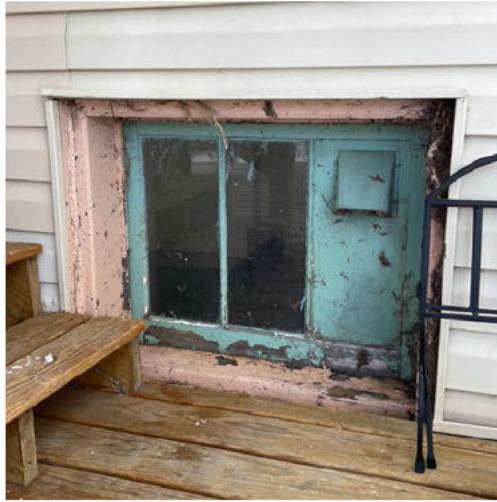
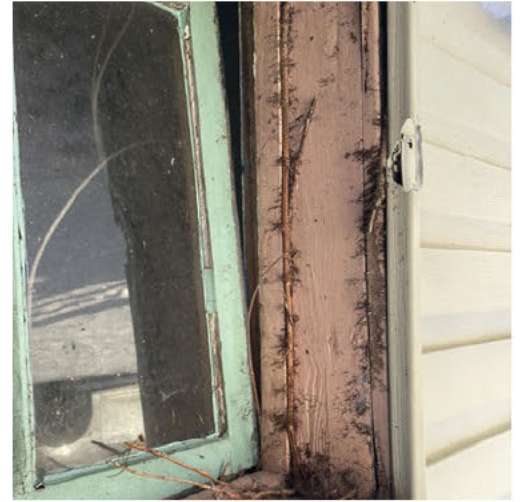
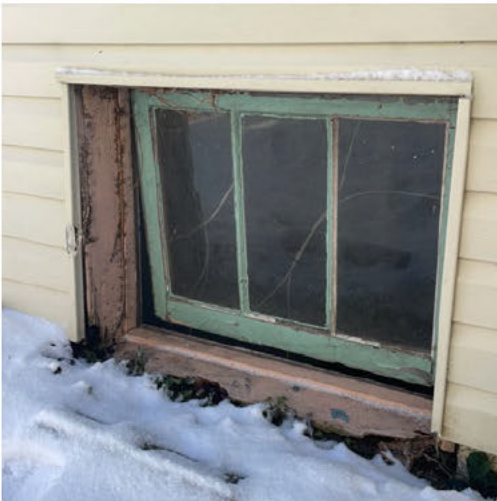
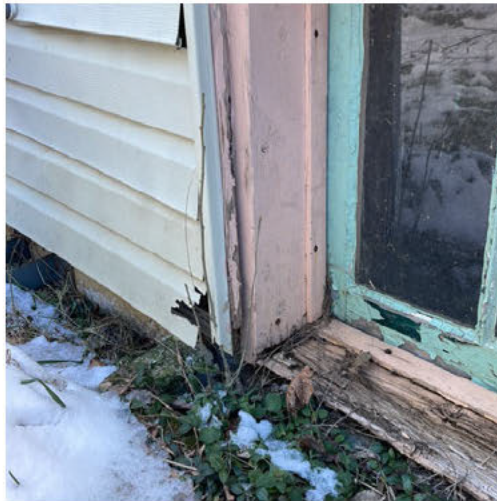
Basement Windows
Around The Property

- Plant roots were found around the exterior window wooden frame as shown in the photos.

- There are signs of wooden rotting around the window wood frame as shown in the photos.

- All the basement windows couldn't properly shut.

- Further evaluation couldn't be performed due to limited access. Highly recommend license contractor to inspect the situation to make sure the plant roots isn't continue growing that will affects the exterior and foundation of the property.

- Highly recommend contractor to perform proper evaluation and repair to prevent further damage and attract termites.

- Further evaluation by window contractor is recommended.

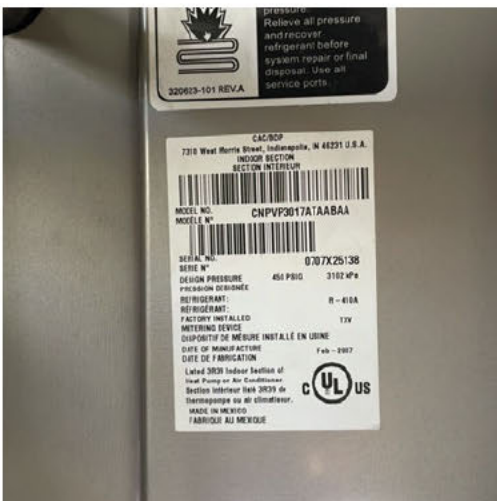
Although the HVAC exceed 15 years lifespan (manufacture year 2007; end year 2022), but annual regular maintenance will increase the HVAC lifespan.

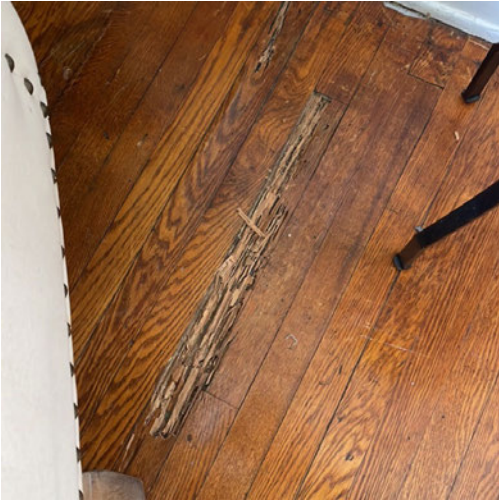
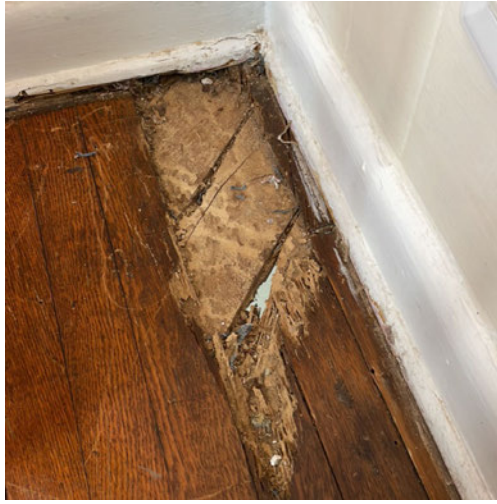
Dining Room

- There is obvious sign of wood damage on the wooden floor as shown on the 1st photo.
- There is severe damage on the wooden floors and the subfloors as shown in 2nd photo.

- Highly recommend further evaluation the situation by a license contractor.

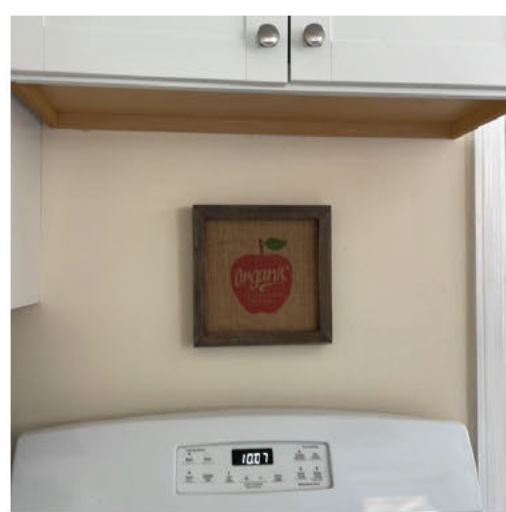
Highly recommend the installation of a cooking range hood.

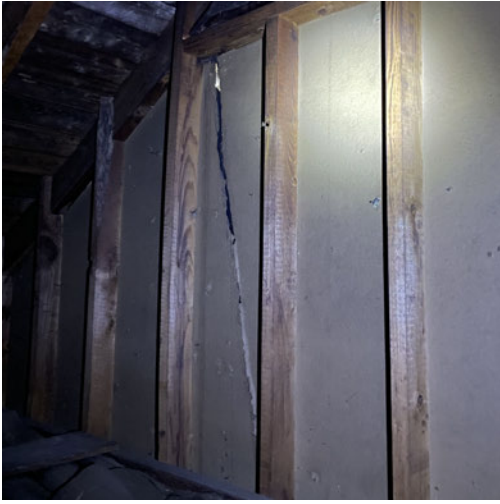
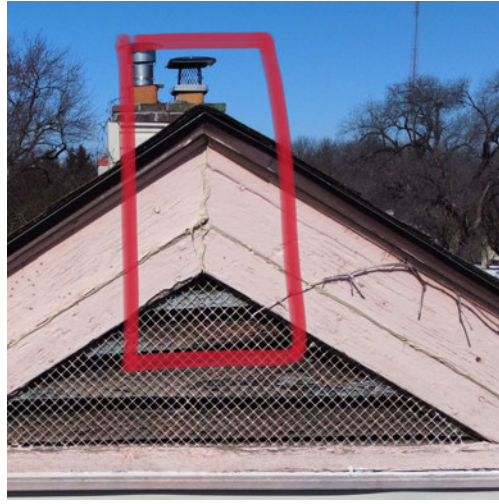
Attic and 2nd Floor
Bedroom Closet (Behind
Bathroom)

Vertical crack was found in the attic dry wall and exterior roof truss. The following were the deficiency comments:

- The vertical crack continued to the 2nd floor bedroom closet (behind bathroom).
- There is no sign of vertical crack in 1st floor drywall and in the basement level.

- This situation is highly recommend a license contractor to perform further evaluation of the condition and the cause of the crack.

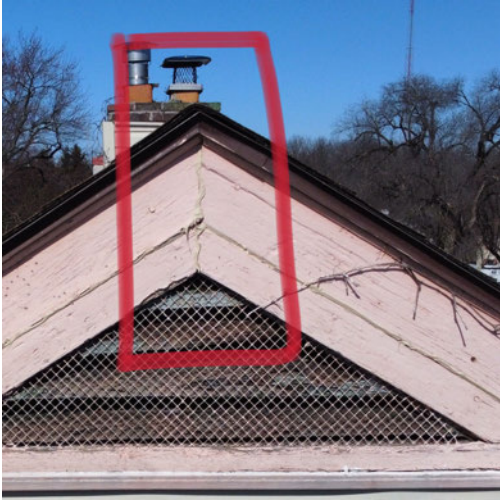
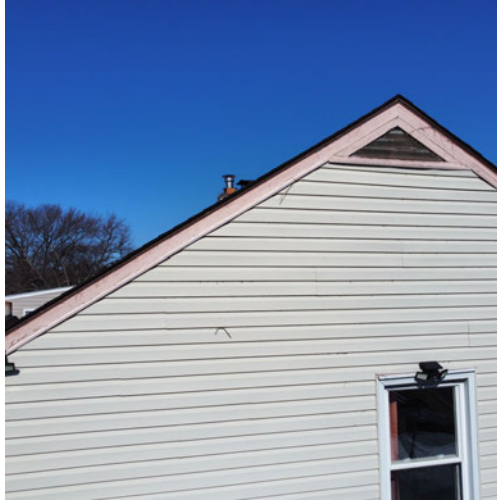
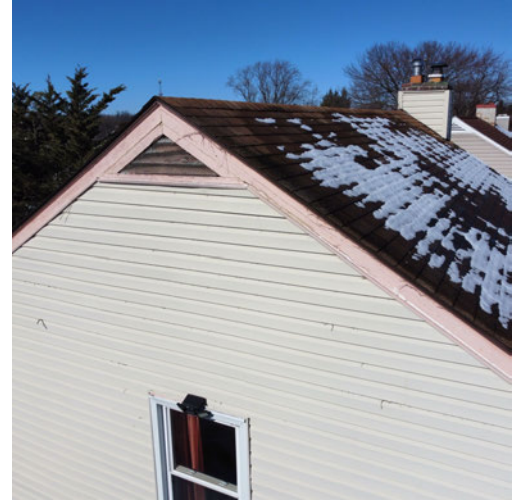
Right Side Of The Roof
Top

- There is a sign of misalignment on the roof truss. The gap that caused by misalignment of the roof truss was filled with white silicon as shown in the photo.
- Tree/plant roots was found on the roof as shown in the photo.
- There are signs of rotten woods as shown in the photos.

- Highly recommend to check the history of the roof truss with current home owner in order to determine the cause of the misalignment.
- Highly recommend license roofing contractor to provide further evaluation of the situation.

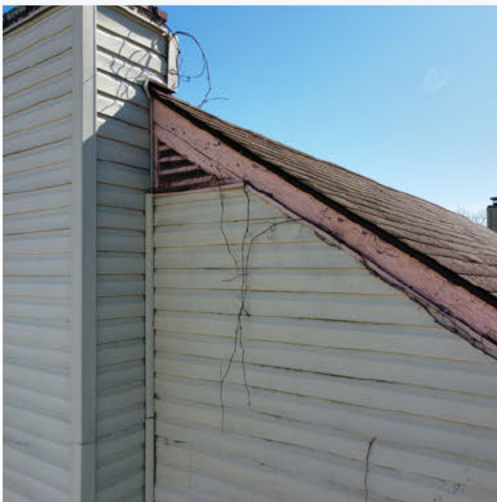
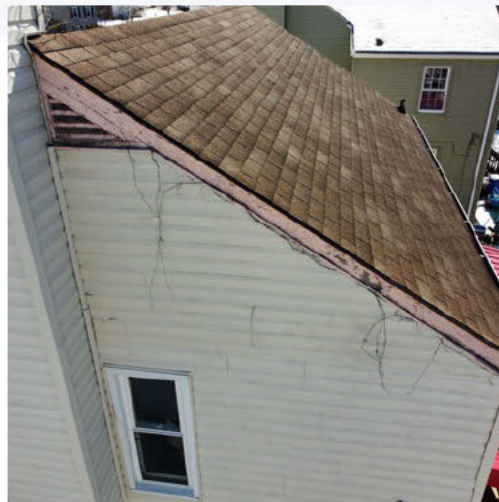
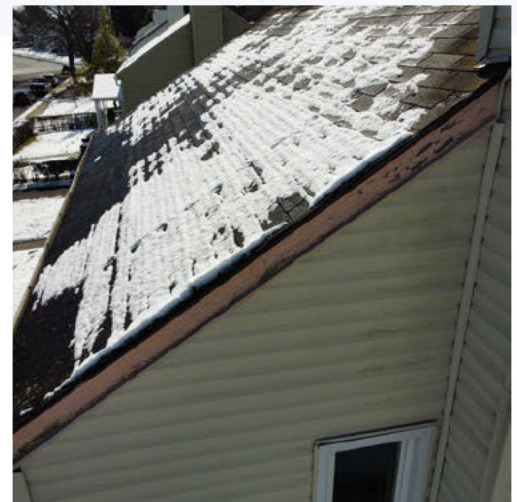
Left Side Of The Roof Top

The following were the comments for the deficiency in this section:

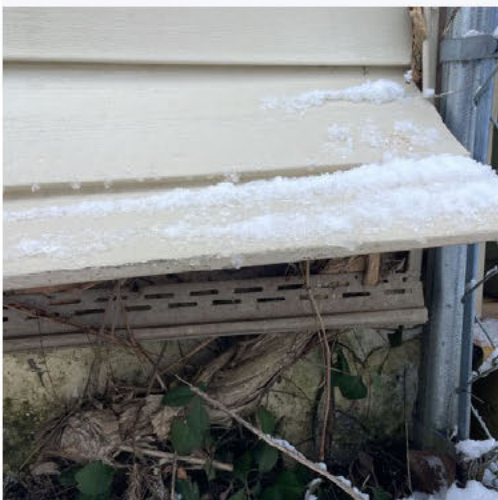
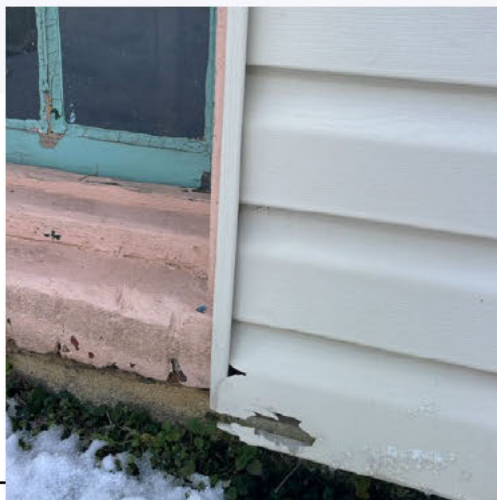
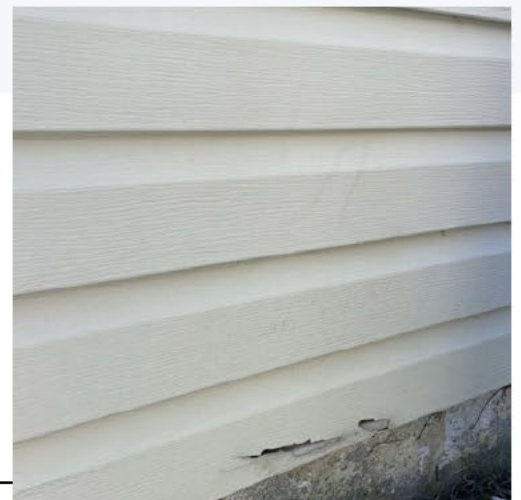
Left Side of The Property

- Tree/plant roots were found behind the vinyl siding and at the corner of the roof as shown in the photos. Couldn't perform further evaluation whether the tree/plant roots is still growing due to limited accessibility.

- Damaged vinyl siding was found as shown in the photos.
- Further evaluation by contractor is required

- Further evaluation by license contractor is highly recommended in order to mitigate the tree/plant roots continue to affect the exterior and foundation of the property.

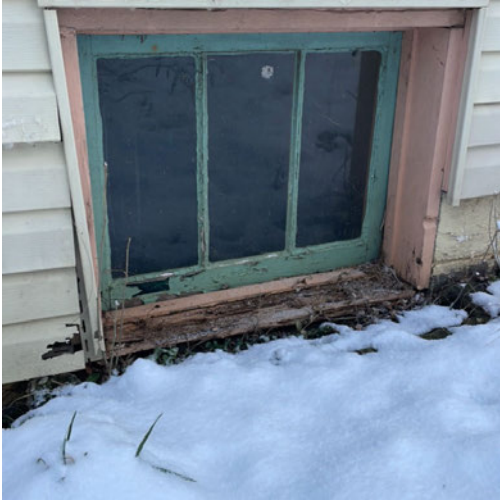
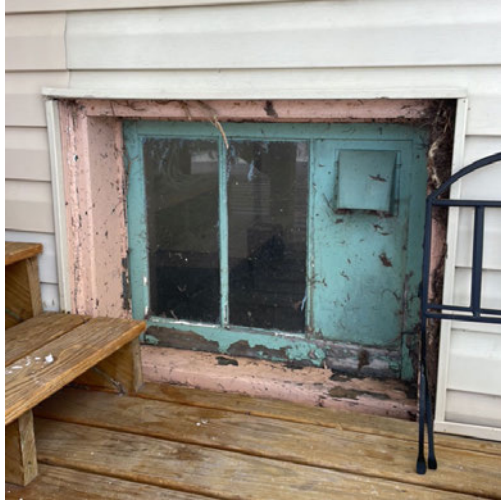
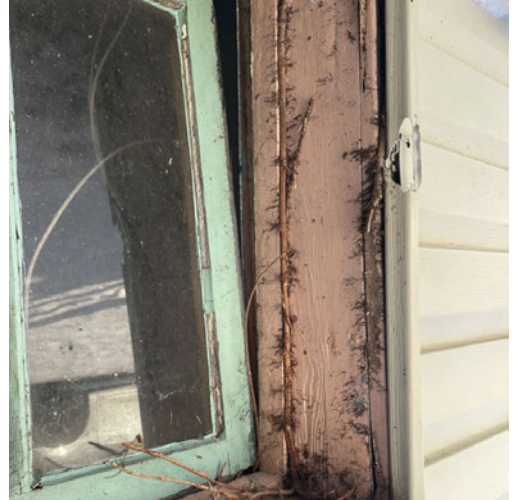
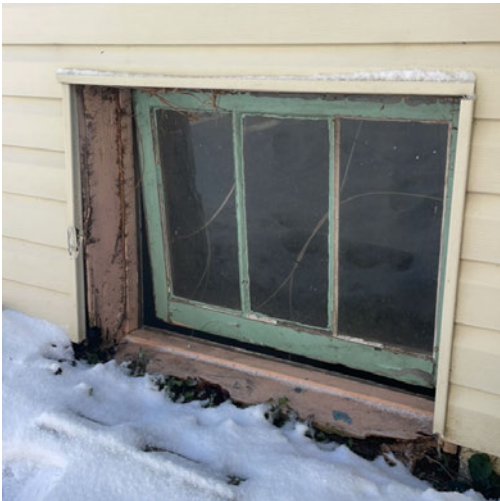
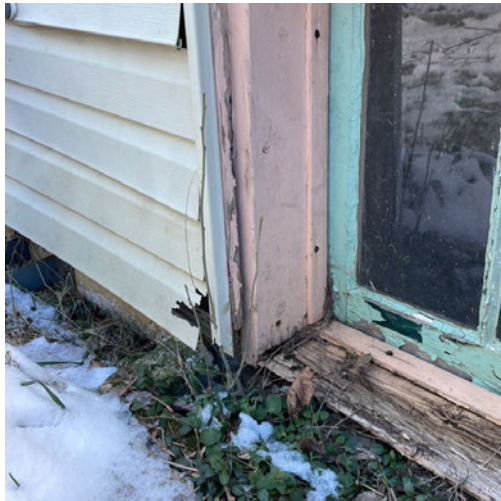
Basement Windows
Around The Property

- Plant roots were found around the exterior window wooden frame as shown in the photos.

- Further evaluation couldn't be performed due to limited access. Highly recommend license contractor to inspect the situation to make sure the plant roots isn't continue growing that will affects the exterior and foundation of the property.

- Highly recommend contractor to perform proper evaluation and repair to prevent further damage and attract termites.

- Further evaluation by window contractor is recommended.

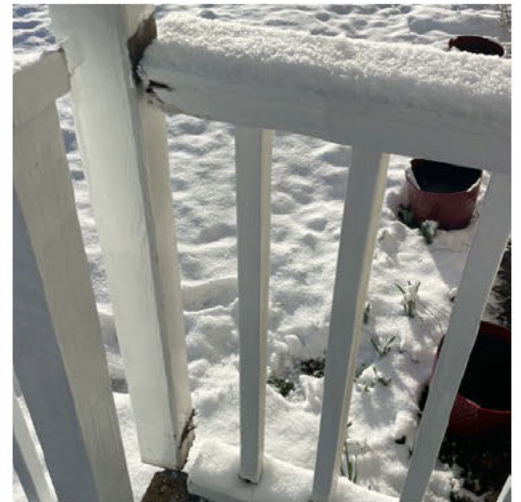
Front Porch

The following shows the comment for deficiency in this section:

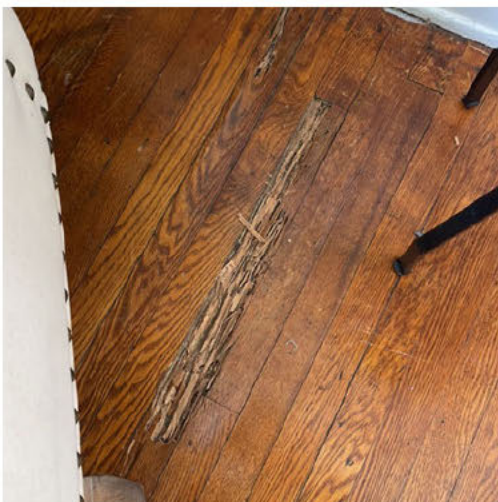
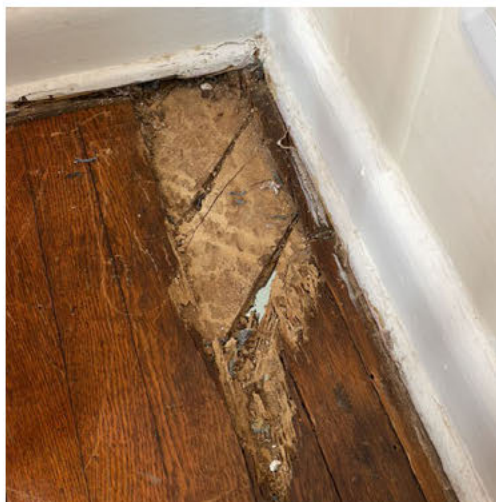
Dining Room

- There is obvious sign of wood damage on the wooden floor as shown on the 1st photo.
- There is severe damage on the wooden floors and the subfloors as shown in 2nd photo.

- Highly recommend further evaluation the situation by a license contractor.

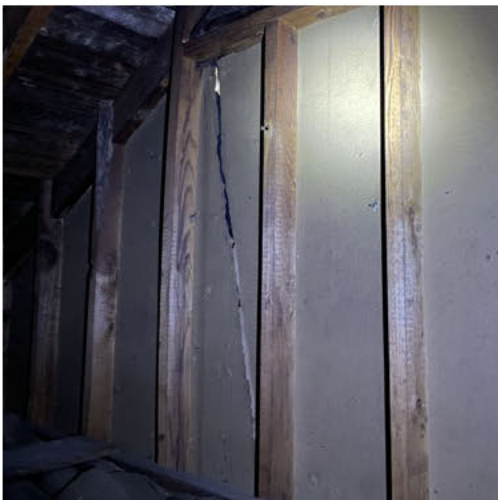
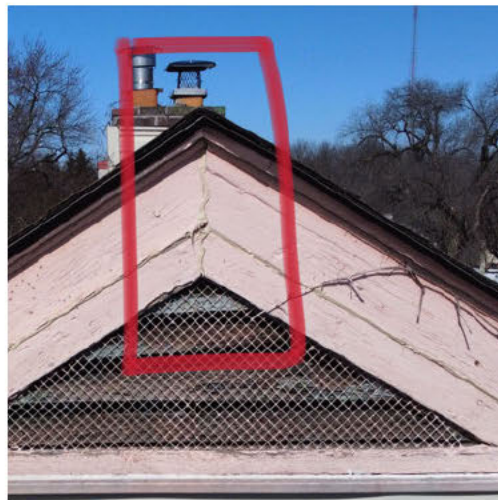
Attic and 2nd Floor
Bedroom Closet (Behind
Bathroom)

Vertical crack was found in the attic dry wall and exterior roof truss. The following were the deficiency comments:

- The vertical crack continued to the 2nd floor bedroom closet (behind bathroom).
- There is no sign of vertical crack in 1st floor drywall and in the basement level.

- This situation is highly recommend a license contractor to perform further evaluation of the condition and the cause of the crack.
