Site Address:

**M.Y Property Inspection LLC**

# REPORT HEADER

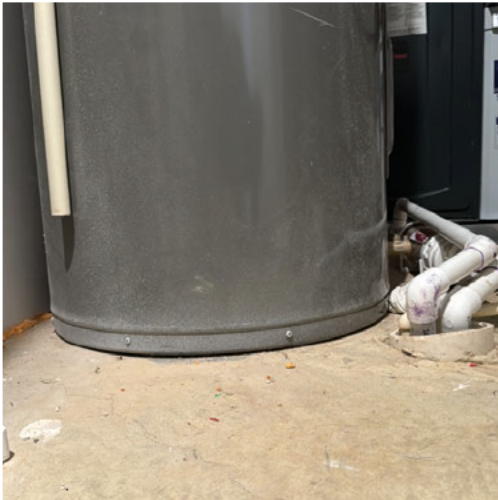
- The grading inside the utility wasn't properly graded and the height of the outlet pipe is higher than the floor, this caused the water discharged from the TPR valve unable to get to the drain outlet.

- Refer to the developer contractor in regards to the grading.
- Extend and connect the TPR pipe to the drainage outlet.

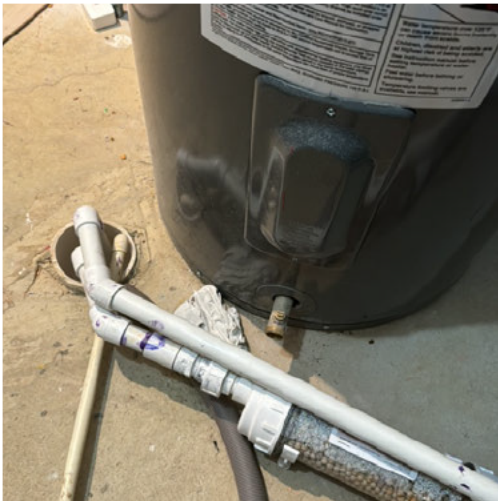
Utility Room

- Pipe setup caused inconvenient to perform maintenance on the water heater in the future.

- Refer to the developer contractor for obtain better solution

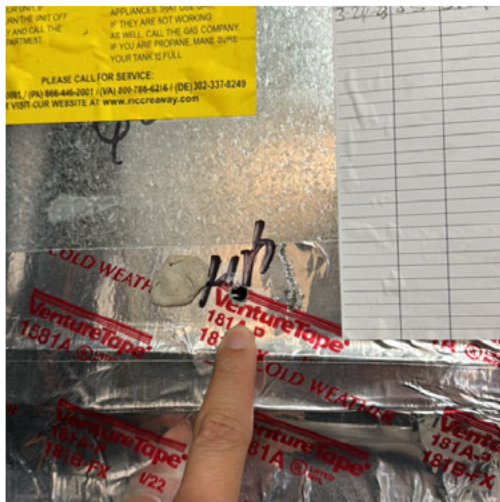
Utility Room

- Hole was found at the furnace.

- Apply additional tape at the location as shown in the photo.

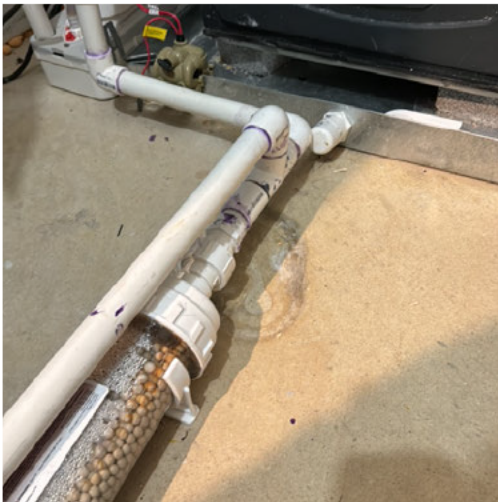
Utility Room

- Water stain was found under the pipe channel as shown in the photo.

- Refer to the developer contractor

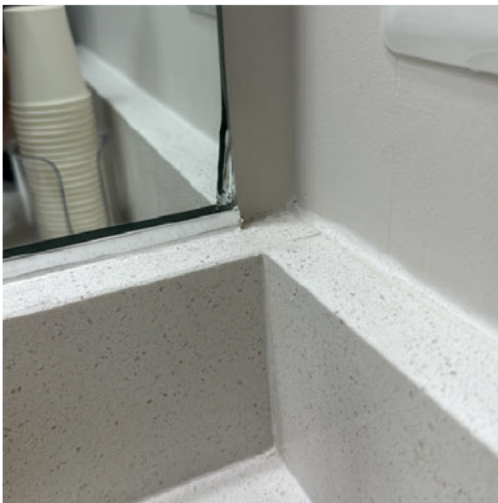
Master Bedroom

- The bottom right corner of the mirror in the bathroom was damaged as shown in the photo.

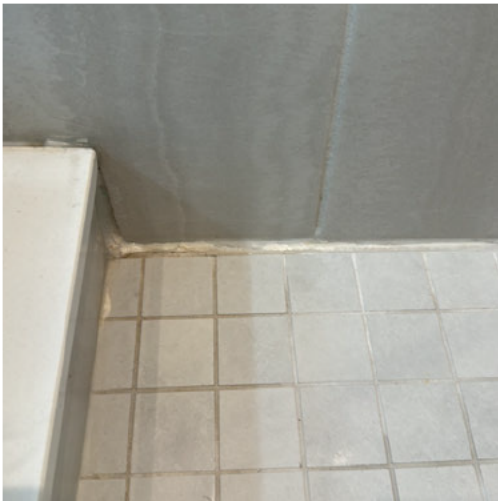
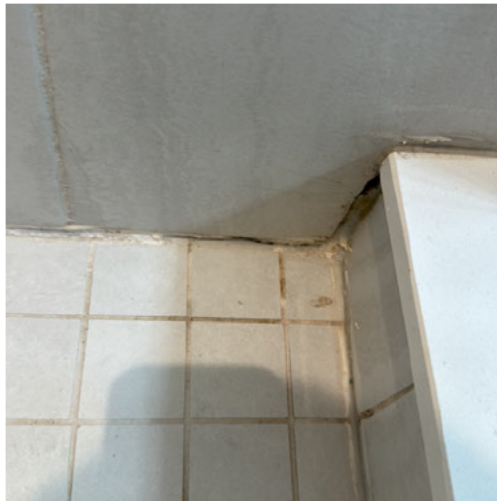
Master Bedroom

- Grout in the shower area started cracking and falling out especially at the corner.

- Refer to the developer contractor to fix the grout.

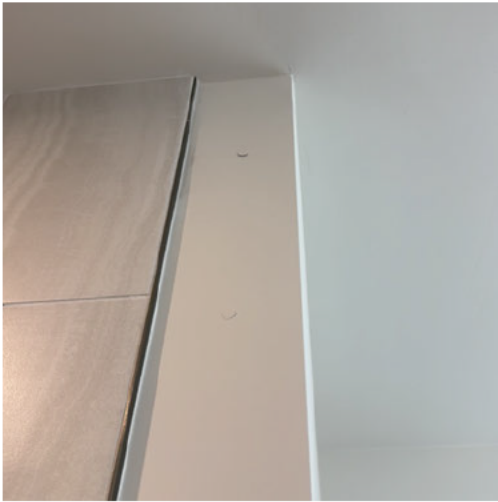
Master Bedroom

- Nail popping out from the drywall.

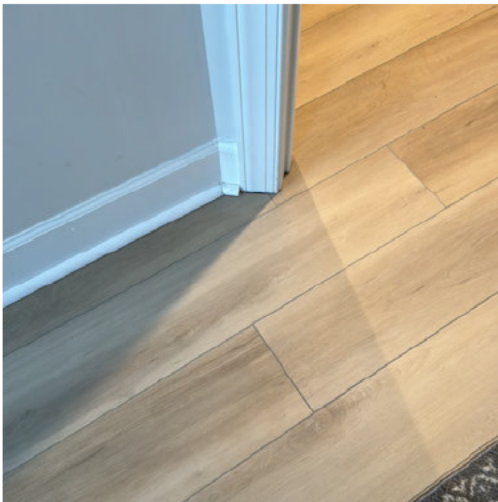
Master Bedroom

- Squeaky sound on the flooring when walk on it.

- Refer to the developer flooring contractor.

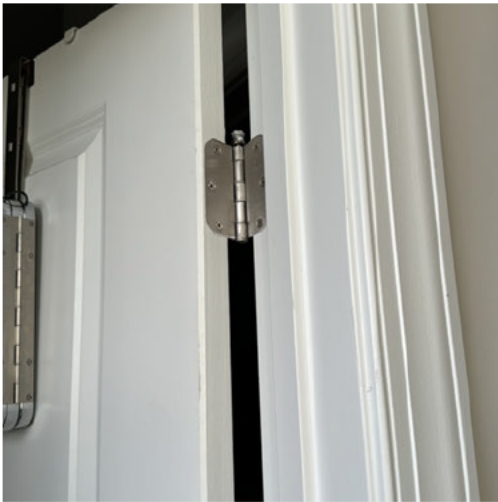
Master Bedroom

- The door hinge in the master bathroom wasn't properly secure in place.

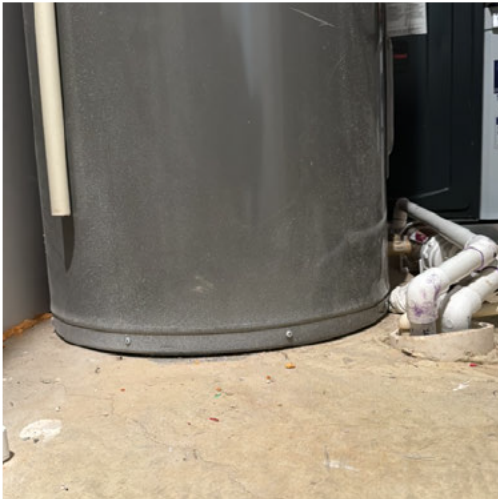
- The grading inside the utility wasn't properly graded and the height of the outlet pipe is higher than the floor, this caused the water discharged from the TPR valve unable to get to the drain outlet.

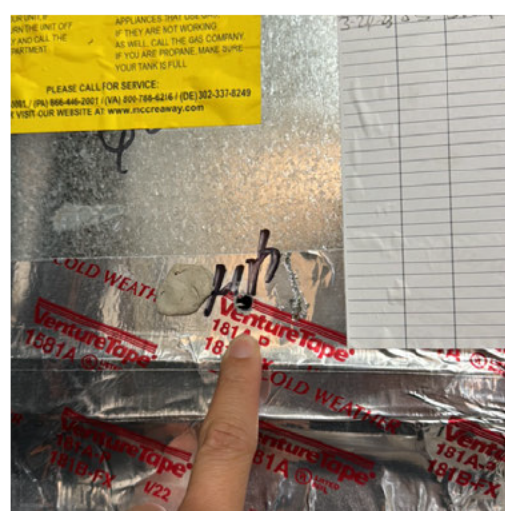
Utility Room

- Hole was found at the furnace.

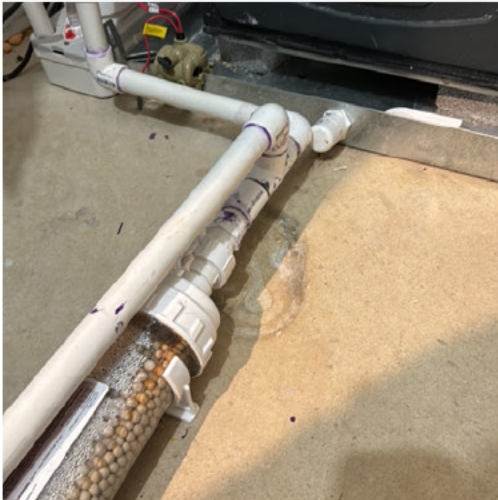
Utility Room

- Water stain was found under the pipe channel as shown in the photo.

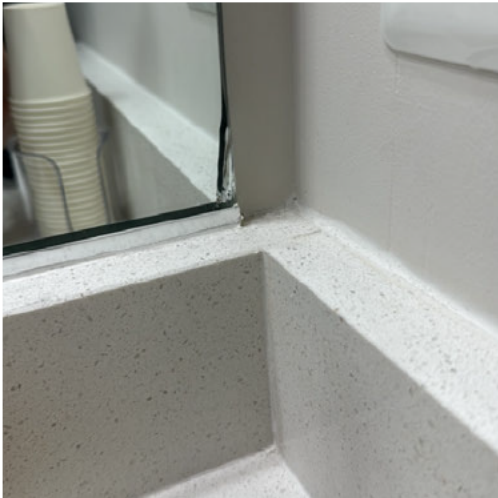
Master Bedroom

- The bottom right corner of the mirror in the bathroom was damaged as shown in the photo.

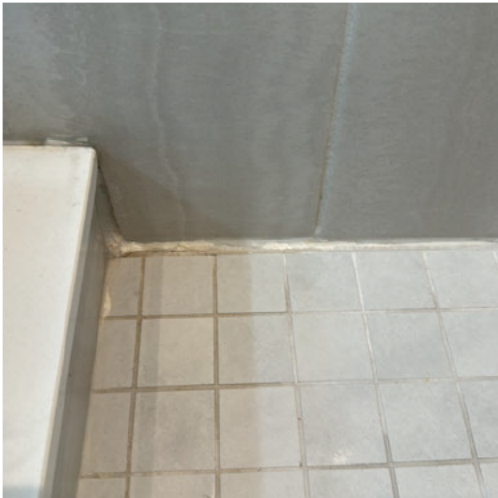
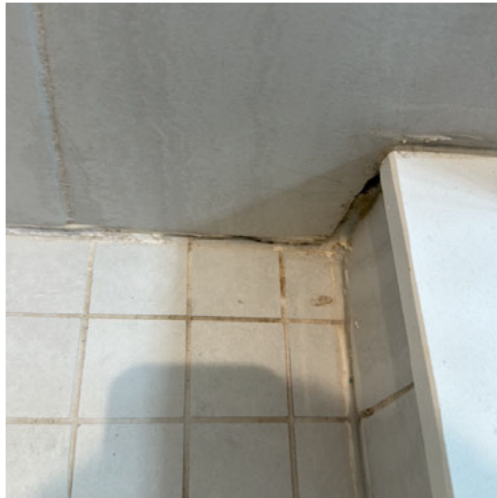
Master Bedroom

- Grout in the shower area started cracking and falling out especially at the corner.
