Inspection Date & Time:

**M.Y Property Inspection LLC**

# REPORT HEADER

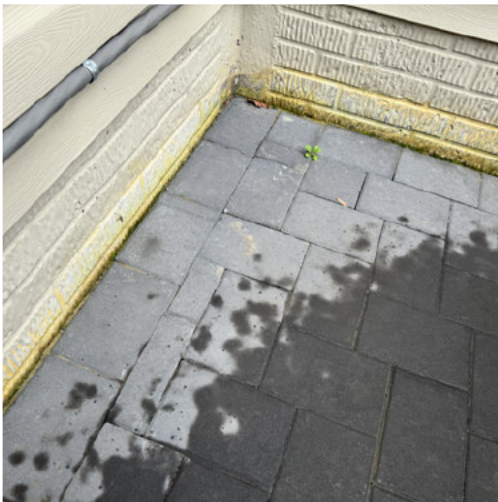
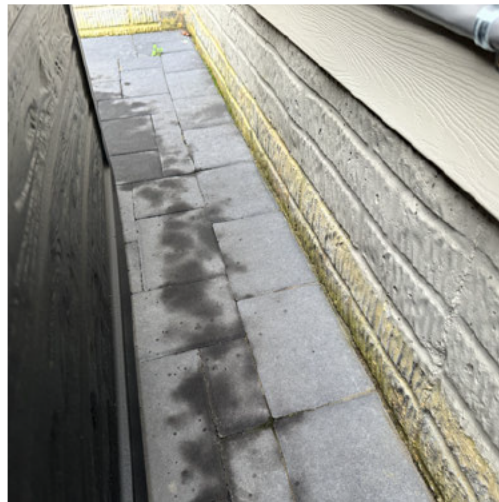
Backyard (Firepit)

- The grout at the joints between the brick and the concrete wall has fallen apart. If the gap doesn't properly filled with grout, the water will infiltrate into the interior wall of the house if there is any cracks that occurs at this area in the future.

- Refer to the developer contractor to apply grout around the joints to prevent water infiltrate through the gaps at the aforementioned location.

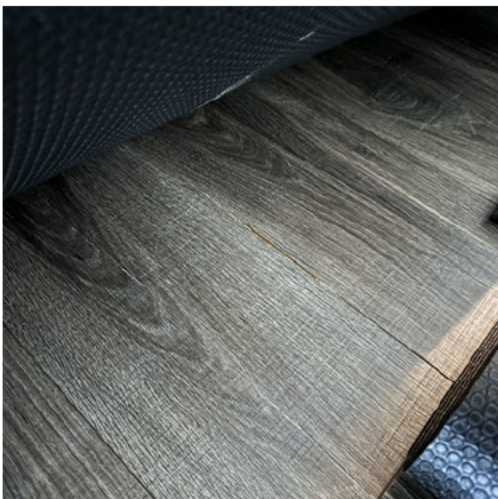
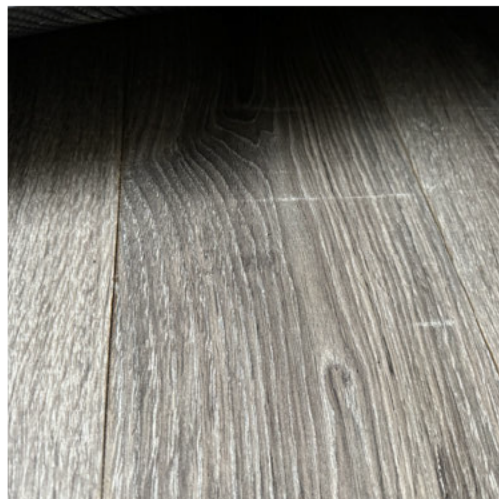
Basement

- The LVP floors at the basement has sign of buckling and water stains between the joints.

- There is a high possibility of moisture exists underneath the LVP floors.

- Highly recommend removal of the LVP floors and inspect the condition below the LVP floors.
- Recommend refer to the developer flooring contractor to evaluate and repair the situation.

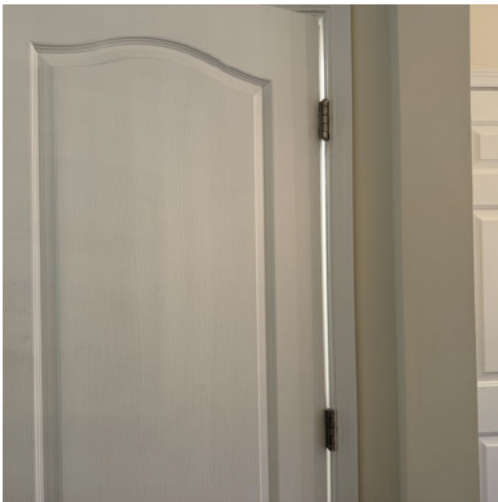
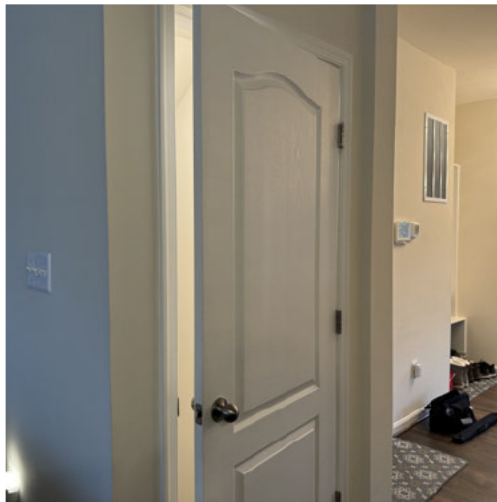
First Floor (Access Door To The Basement)

- The door doesn't properly close.

- Refer to the developer contractor to evaluate the situation by adjusting the door hinges.

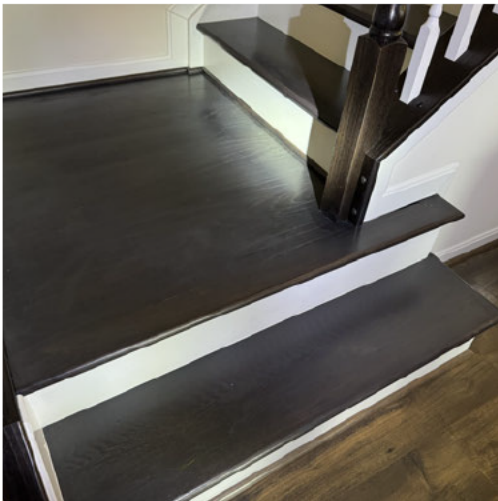
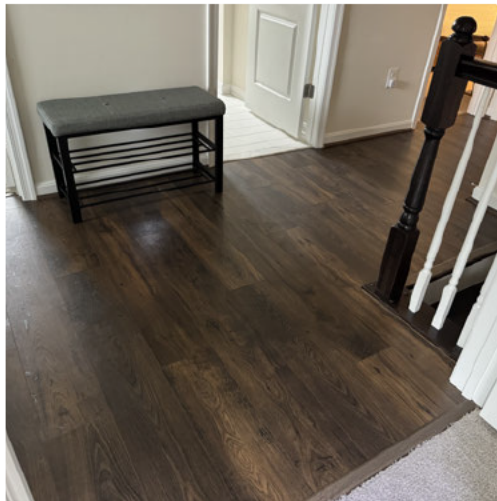
Stair Landing & Second Floor Hallway

- The floors at the stair landing and second floor hallway have squeaky noise when walk on it.
- The joint for the stair nose at the stair landing has sign of opening as shown in the photo.

- Refer to developer flooring contractor to evaluate the situation.

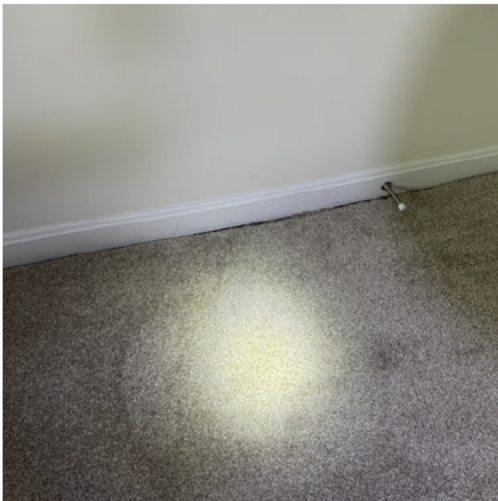
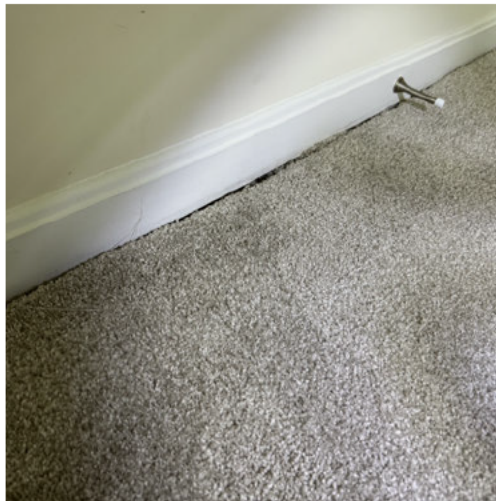
Master Bedroom

- The floor underneath the carpet as shown in the photo have sign of uneven surface and not stable when walk on it.
- The carpet finishing under the baseboard wasn't properly installed.

- Highly recommend refer to the developer flooring contractor to evaluate and inspect the situation and perform required repair on the above items.

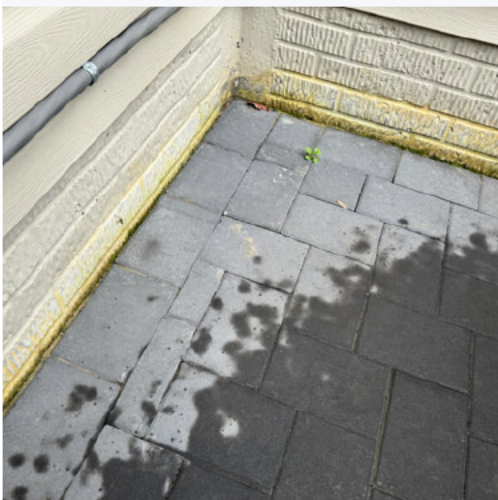
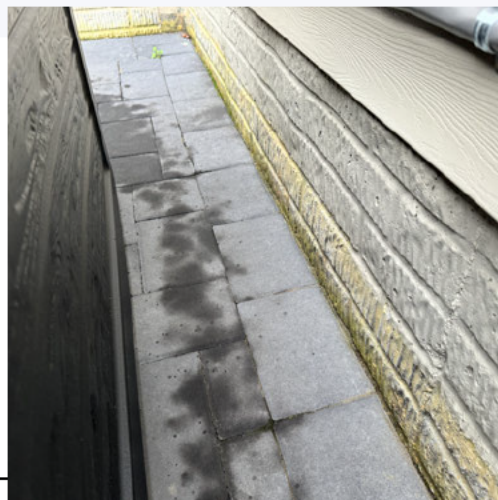
Backyard (Firepit)

- The grout at the joints between the brick and the concrete wall has fallen apart. If the gap doesn't properly filled with grout, the water will infiltrate into the interior wall of the house if there is any cracks that occurs at this area in the future.

- Refer to the developer contractor to apply grout around the joints to prevent water infiltrate through the gaps at the aforementioned location.

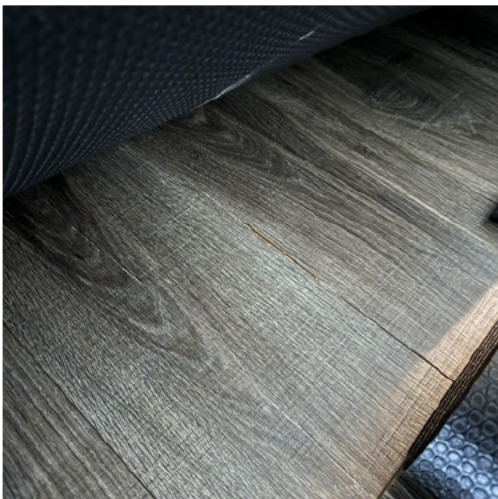
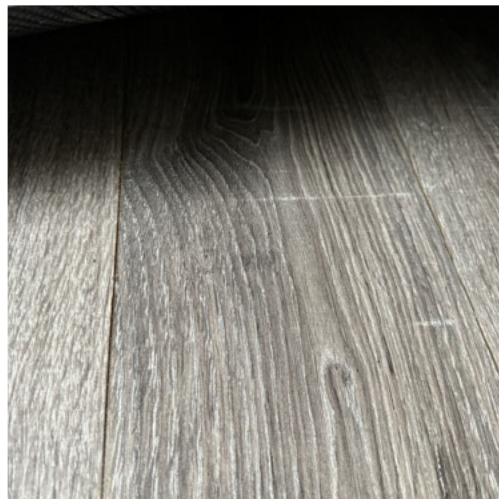
Basement

- The LVP floors at the basement has sign of buckling and water stains between the joints.

- There is a high possibility of moisture exists underneath the LVP floors.

- Highly recommend removal of the LVP floors and inspect the condition below the LVP floors.
- Recommend refer to the developer flooring contractor to evaluate and repair the situation.

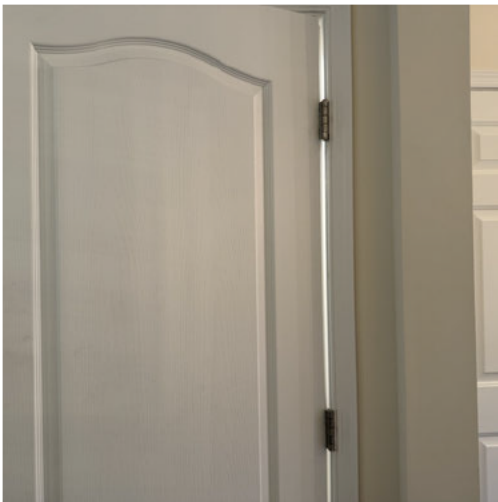
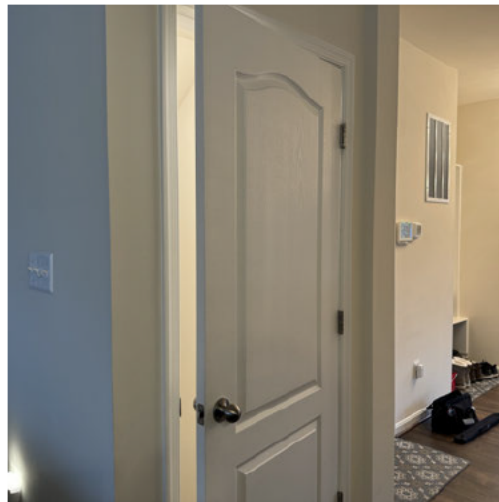
First Floor (Access Door To The Basement)

- The door doesn't properly close.

- Refer to the developer contractor to evaluate the situation by adjusting the door hinges.

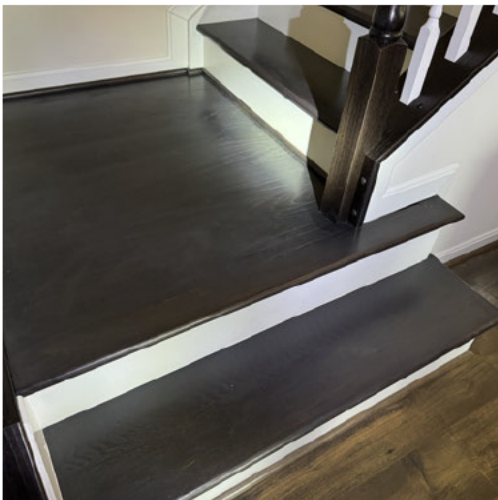
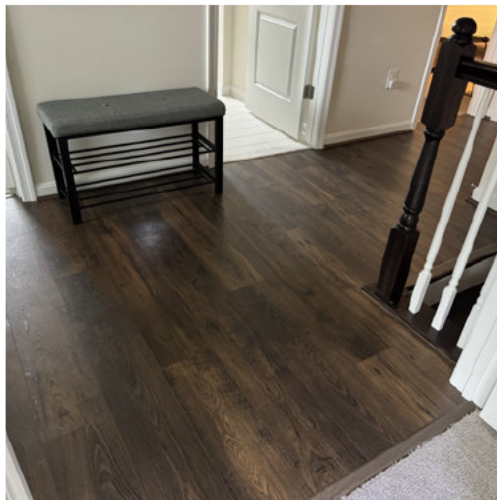
Stair Landing & Second Floor Hallway

- The floors at the stair landing and second floor hallway have squeaky noise when walk on it.
- The joint for the stair nose at the stair landing has sign of opening as shown in the photo.

- Refer to developer flooring contractor to evaluate the situation.

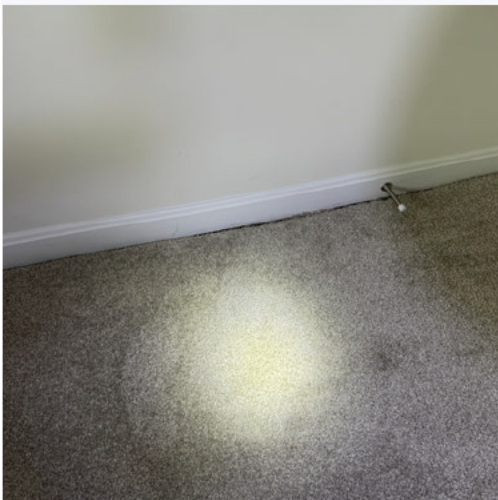
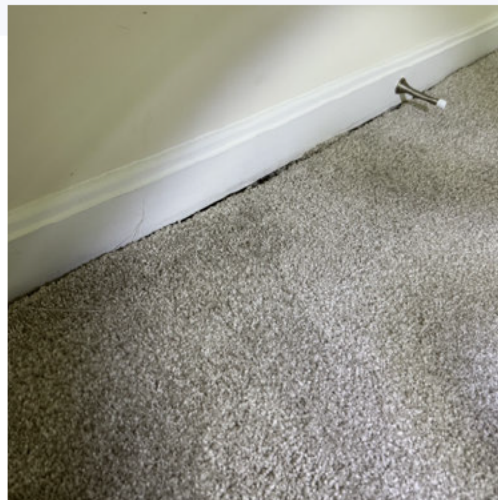
Master Bedroom

- The floor underneath the carpet as shown in the photo have sign of uneven surface and not stable when walk on it.
- The carpet finishing under the baseboard wasn't properly installed.

- Highly recommend refer to the developer flooring contractor to evaluate and inspect the situation and perform required repair on the above items.
