M.Y Property Inspection LLC

REPORT HEADER

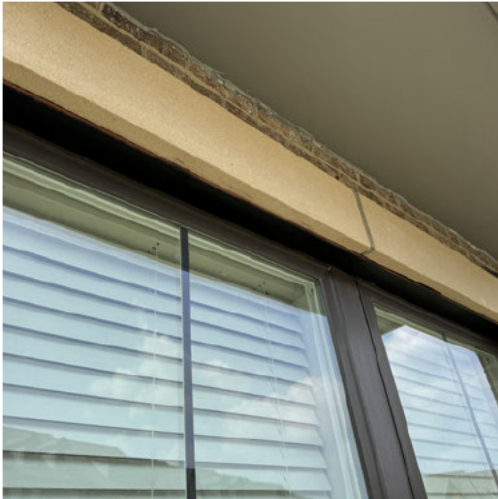
Lintel (All the Windows Opening)

- The front side of the lintel wasn't painted with protective paint.

- Refer to the developer to evaluate the situation and perform proper maintenance to prevent the lintel from rusting.

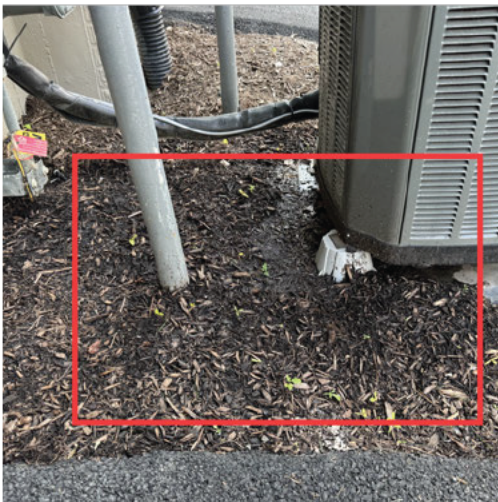
HVAC Water Line
(Backyard)

- The area that shown in the photo is really soft when step on it, highly suspect there are significant amount of water in the ground.
- The reason is due to significant amount of water discharged from the HVAC water line.

- Highly recommend refer to the developer contractor to evaluate the situation.
- Recommend to modify the water line in order for the water to be discharge away from the house as discussed during the inspection.

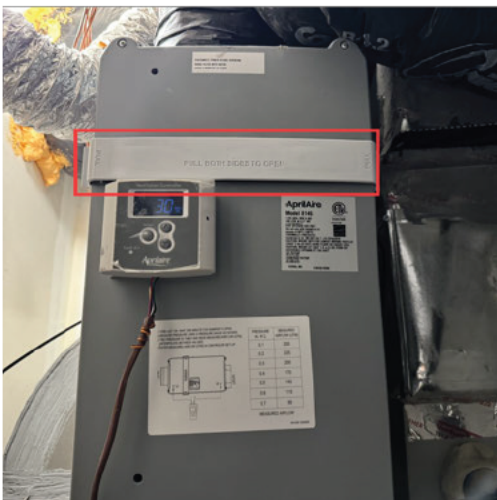
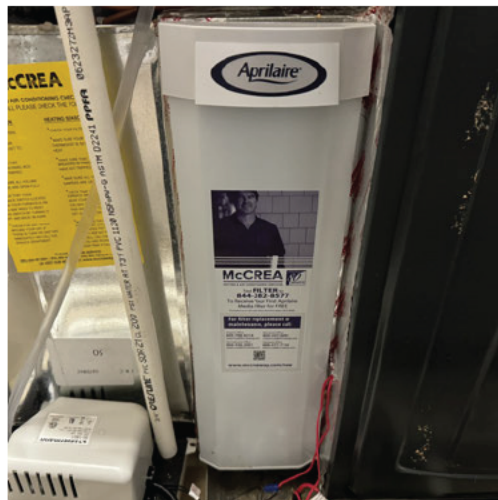
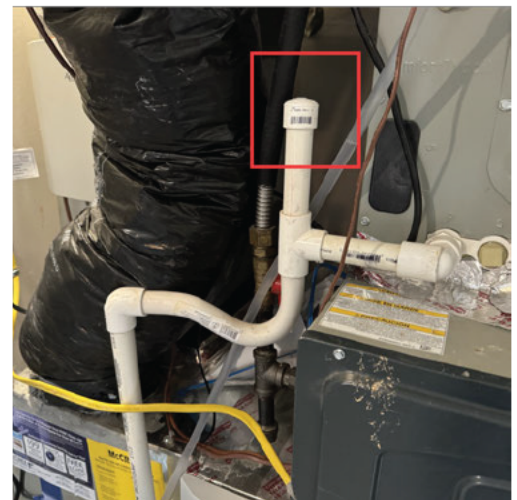
HVAC Maintenance

- The air filter is highly recommend to change every 2 to 3 months.
- The filter at the air handler is highly recommend to perform maintenance every 6 months by washing and drying it.
- Unlock the white cap at the PVC drain pipe to make sure it wasn't clog.
- Highly recommend to perform general maintenance on the HVAC, Furnace, and Water Heater every 2 years.

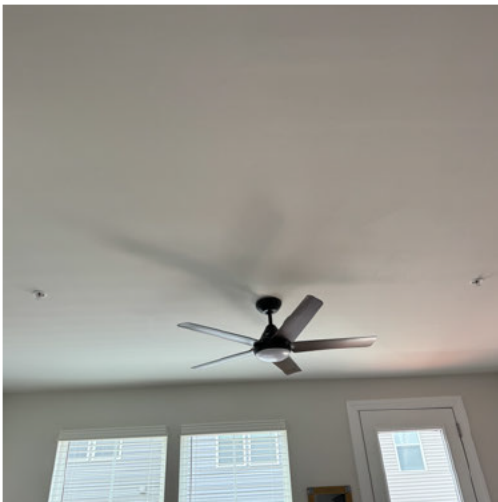
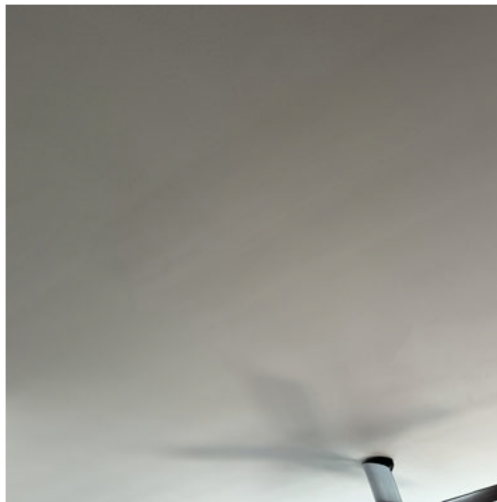
Living Room

- Vibration sound was heard in the living room when the family member in the house using the bathroom in the third floor.
- Highly suspect the vibration noise is due to the plumbing wasn't firmly secure to the beam during construction.

- Highly recommend refer to the developer construction team to evaluate the situation.

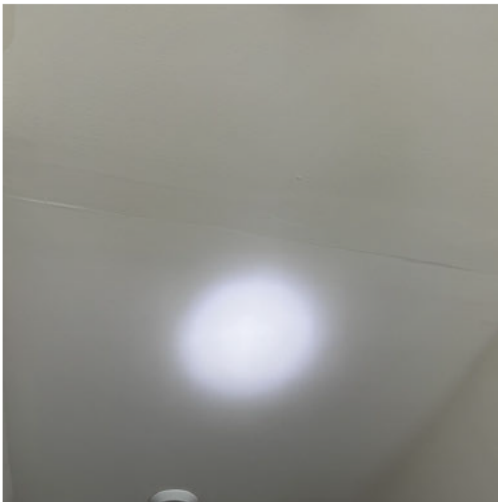
Top Floor Bedroom

- There is a visible line on the ceiling in the top floor bedroom.

- Highly recommend refer to the developer construction team to evaluate the situation and perform proper repairs.

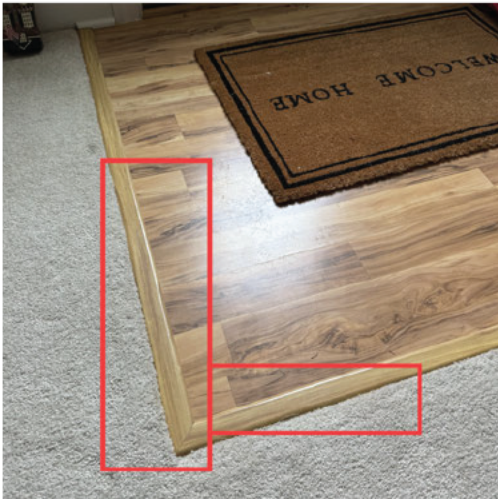
Front Door Transition Strip

- The vinyl floor transition strip doesn't properly secure to the floor and caused movement.

- Highly recommend refer to the developer flooring contractor to evaluate and perform proper repair at the situation.

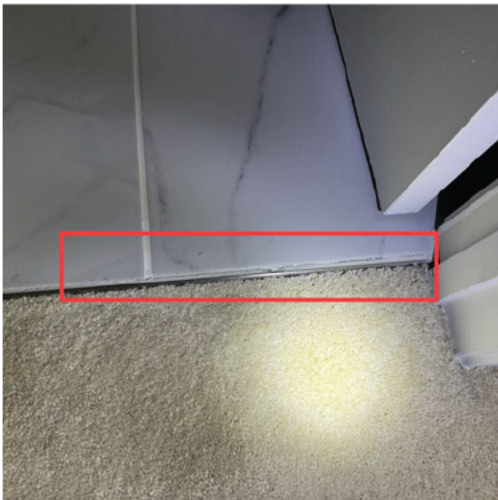
Third Floor Bathroom

- The tile transition strip doesn't properly secure to the floor.
- The grout acts as a adhesive material started falling apart.

- Highly recommend refer to the developer flooring contractor to evaluate and perform proper repair at the situation.

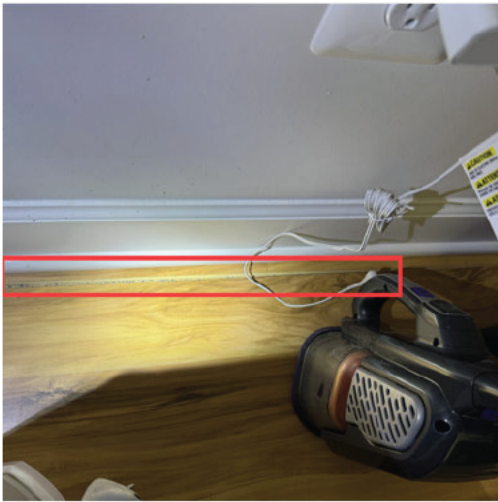
Edge between Second Floor Bathroom and Staircase

- The vinyl floor plank doesn't properly secure in place and caused sliding as shown in the photos.

- Highly recommend refer to the developer flooring contractor to evaluate and perform proper repair at the situation.

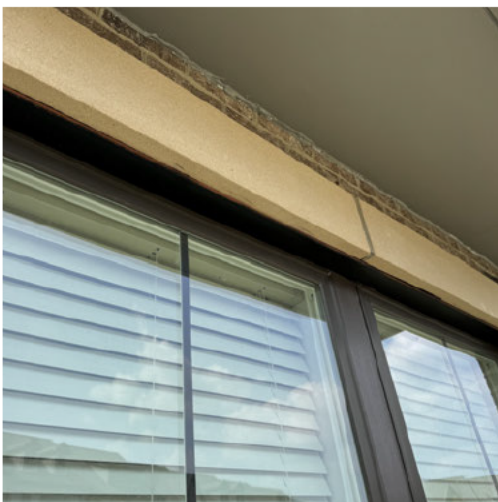
Lintel (All the Windows Opening)

- The front side of the lintel wasn't painted with protective paint.

- Refer to the developer to evaluate the situation and perform proper maintenance to prevent the lintel from rusting.

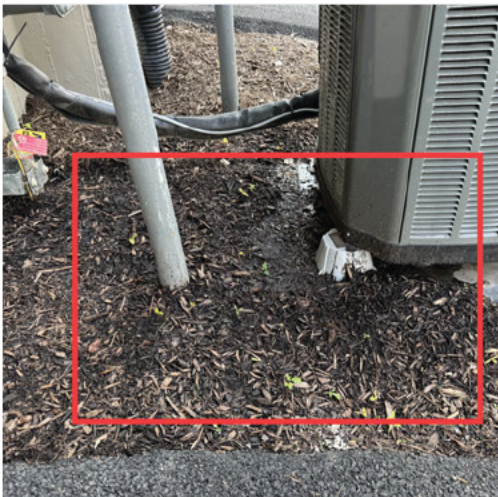
HVAC Water Line
(Backyard)

- The area that shown in the photo is really soft when step on it, highly suspect there are significant amount of water in the ground.
- The reason is due to significant amount of water discharged from the HVAC water line.

- Highly recommend refer to the developer contractor to evaluate the situation.
- Recommend to modify the water line in order for the water to be discharge away from the house as discussed during the inspection.

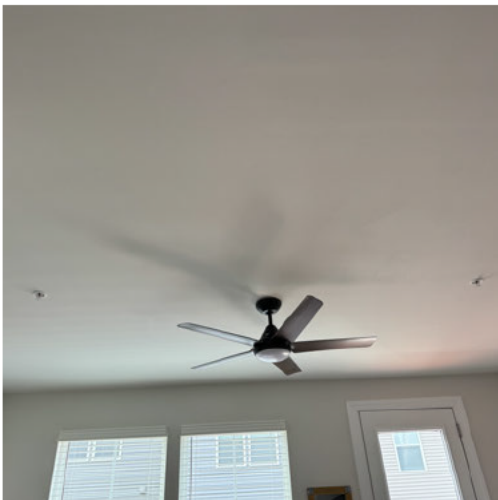
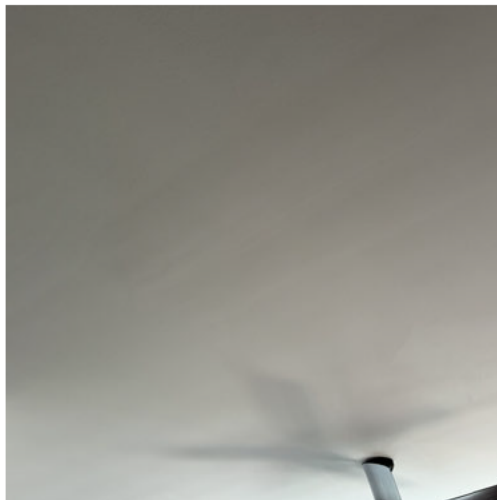
Living Room

- Vibration sound was heard in the living room when the family member in the house using the bathroom in the third floor.
- Highly suspect the vibration noise is due to the plumbing wasn't firmly secure to the beam during construction.

- Highly recommend refer to the developer construction team to evaluate the situation.

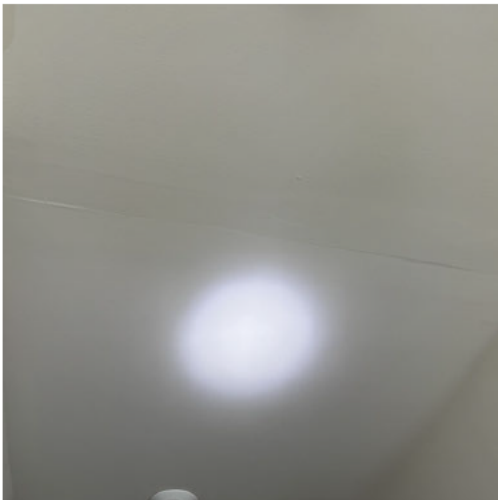
Top Floor Bedroom

- There is a visible line on the ceiling in the top floor bedroom.

- Highly recommend refer to the developer construction team to evaluate the situation and perform proper repairs.

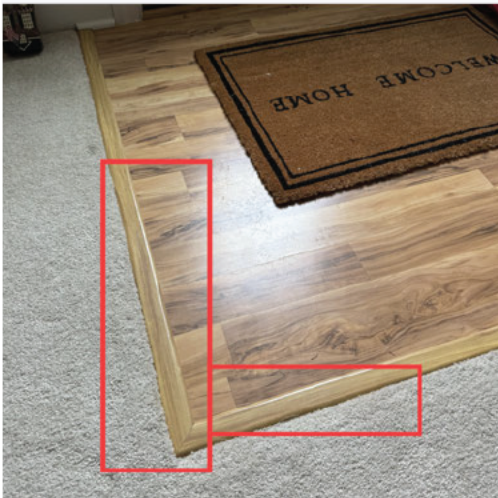
Front Door Transition Strip

- The vinyl floor transition strip doesn't properly secure to the floor and caused movement.

- Highly recommend refer to the developer flooring contractor to evaluate and perform proper repair at the situation.

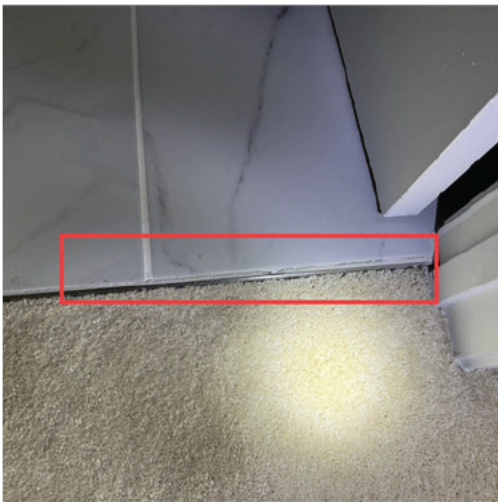
Third Floor Bathroom

- The tile transition strip doesn't properly secure to the floor.
- The grout acts as a adhesive material started falling apart.

- Highly recommend refer to the developer flooring contractor to evaluate and perform proper repair at the situation.

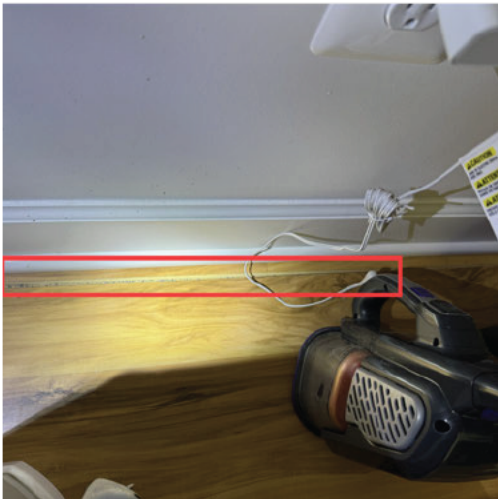
Edge between Second Floor Bathroom and Staircase

- The vinyl floor plank doesn't properly secure in place and caused sliding as shown in the photos.

- Highly recommend refer to the developer flooring contractor to evaluate and perform proper repair at the situation.
