**M.Y Property Inspection LLC**

REPORT HEADER

1: GENERAL

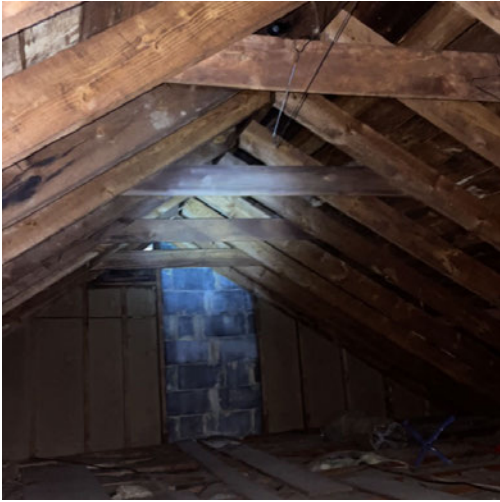
Roof Structure Images:

- There is a sign of misalignment on the roof truss. The gap that caused by misalignment of the roof truss was filled with white silicon as shown in the photo.
- Tree/plant roots was found on the roof as shown in the photo.
- There are signs of rotten woods as shown in the photos.

- Highly recommend to check the history of the roof truss with current home owner in order to determine the cause of the misalignment.
- Highly recommend license roofing contractor to provide further evaluation of the situation.
