M.Y Property Inspection LLC

REPORT HEADER

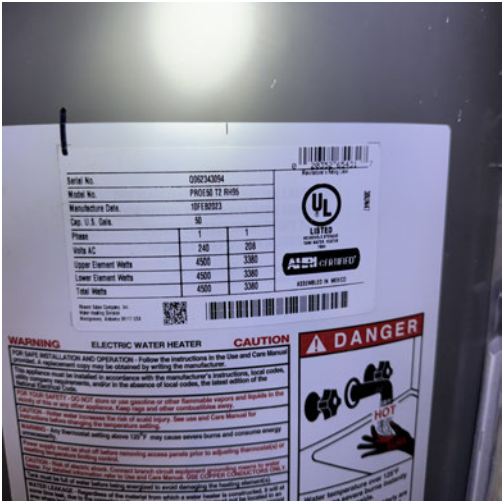
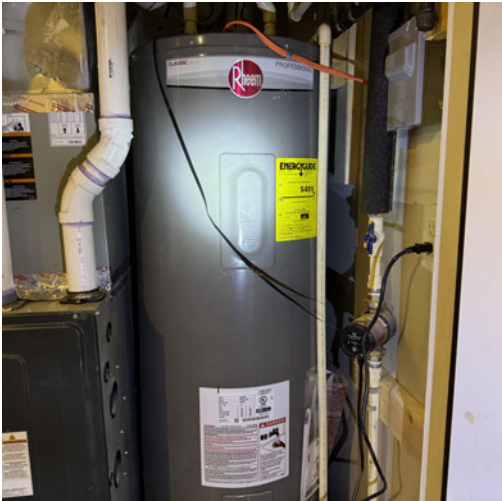
Location Images:

Location:	Type:
Utility Room	Tank
Energy Source:	Manufacturer:
Electric	Rheem
Manufactured Year:	Capacity:
2023	50 Gallon
Functionality:	
Operational

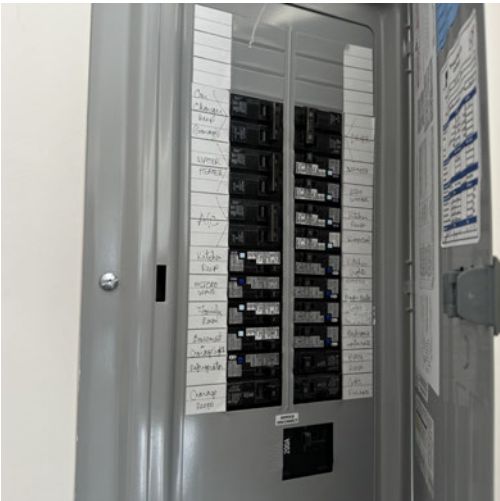
Location Images:

Location:	Panel Manufacturer:
First Level	Siemens
Panel Amperage Rating:	Disconnect Amperage Rating:
200 amp	200 amp
Predominant Branch Circuit Wiring Method:	
Copper NM

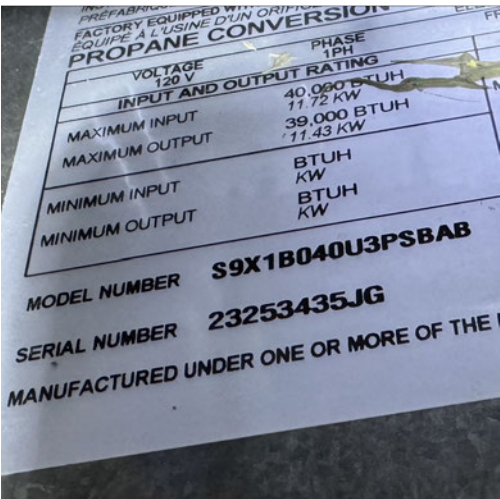
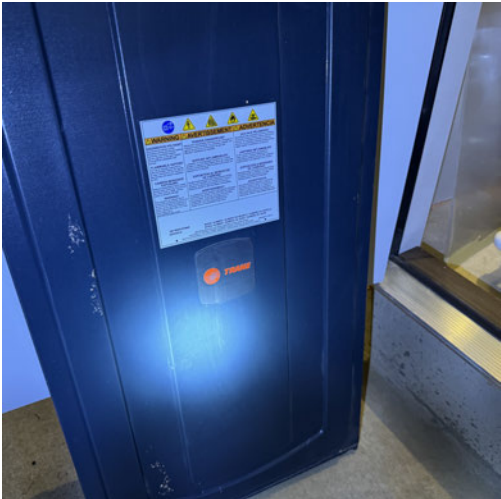
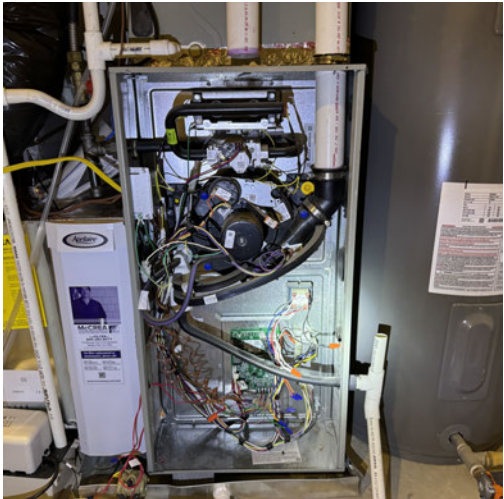
Equipment Type Images:

Equipment Type: High Efficiency Furnace	Equipment Location: Utility Room
Equipment Manufacturer: Trane	Manufactured Year: 2023
Fuel/Energy Source: Electric	Auxiliary Heating Type: Not Present
Emergency Heating Type: Not Present	Functionality: Operational

- The air filter is highly recommend to change every 2 to 3 months.
- The filter at the air handler is highly recommend to perform maintenance every 6 months by washing and drying it.
- Unlock the white cap at the PVC drain pipe to make sure it wasn't clog.
- Highly recommend to perform general maintenance on the HVAC, Furnace, and Water Heater every 2 years.
